# LLNL Site 300 CERCLA Groundwater Cleanup Project Corral Fire Update

Site 300 CERCLA Remedial Project Managers (RPM) Meeting

June 25, 2024

DOE / LLNL  
Environmental Restoration Department

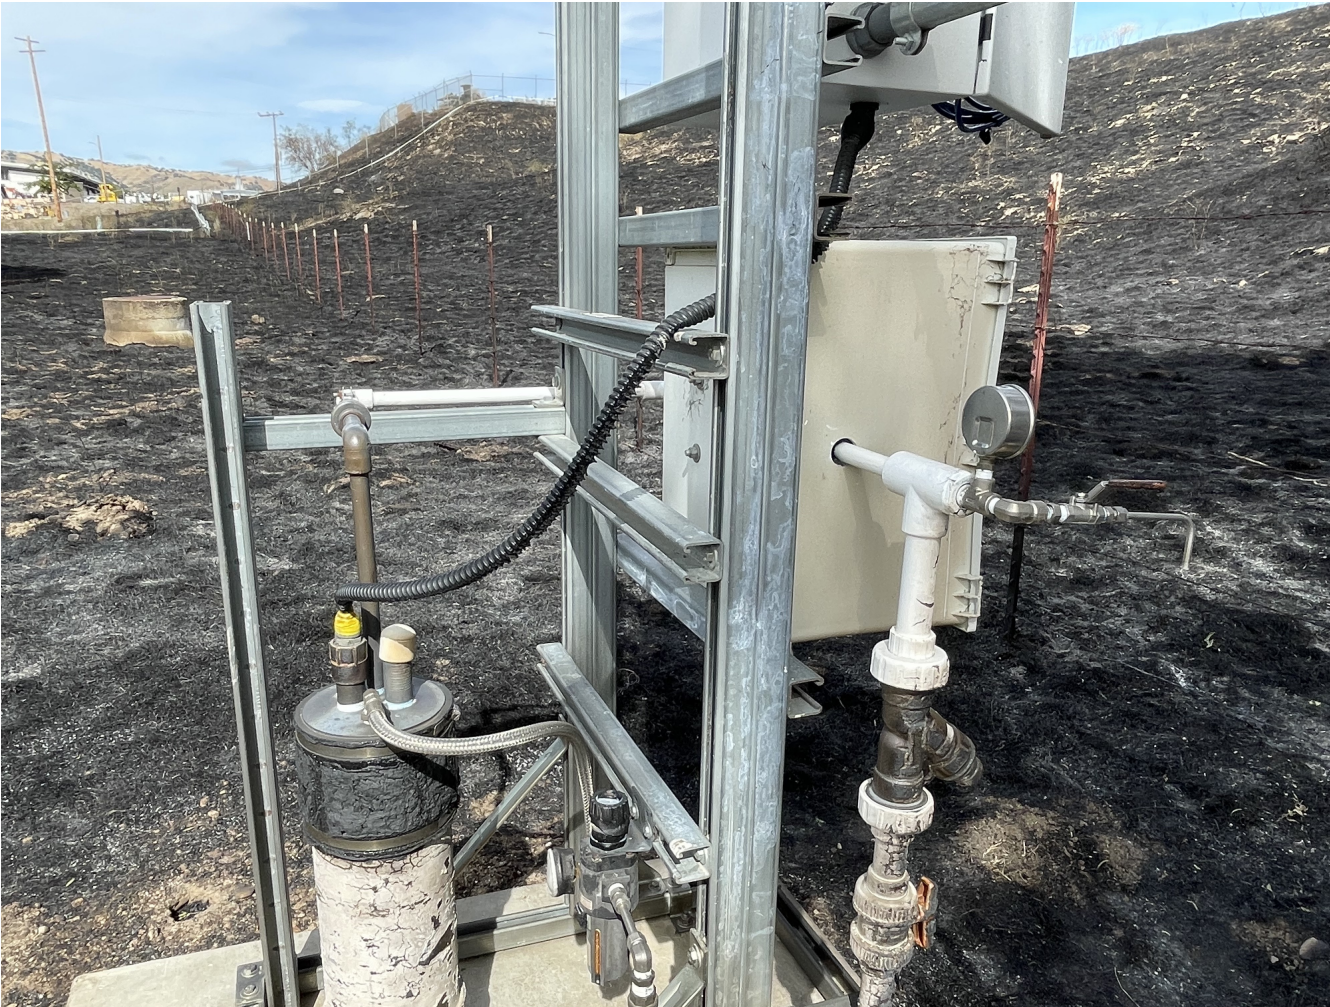
CGSA GWTS was damaged by the fire.

CGSA GWTS extraction well W-7P. Significant damage.

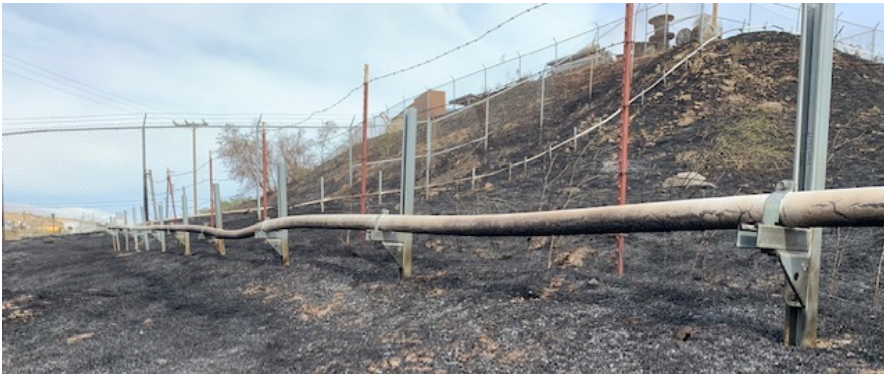
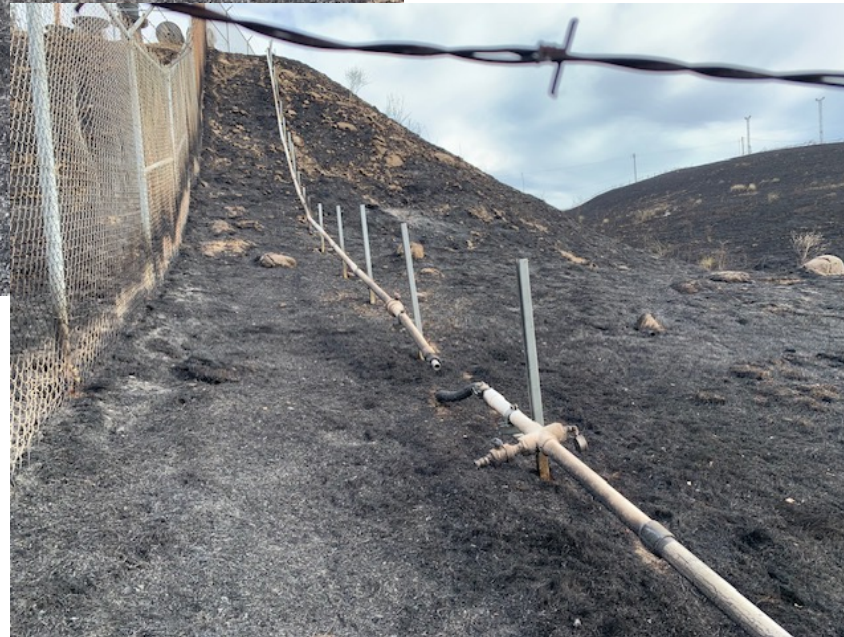
CGSA GWTS was damaged by the fire.

CGSA GWTS effluent pipeline. Significant damage to PVC pipes and expansion joints.

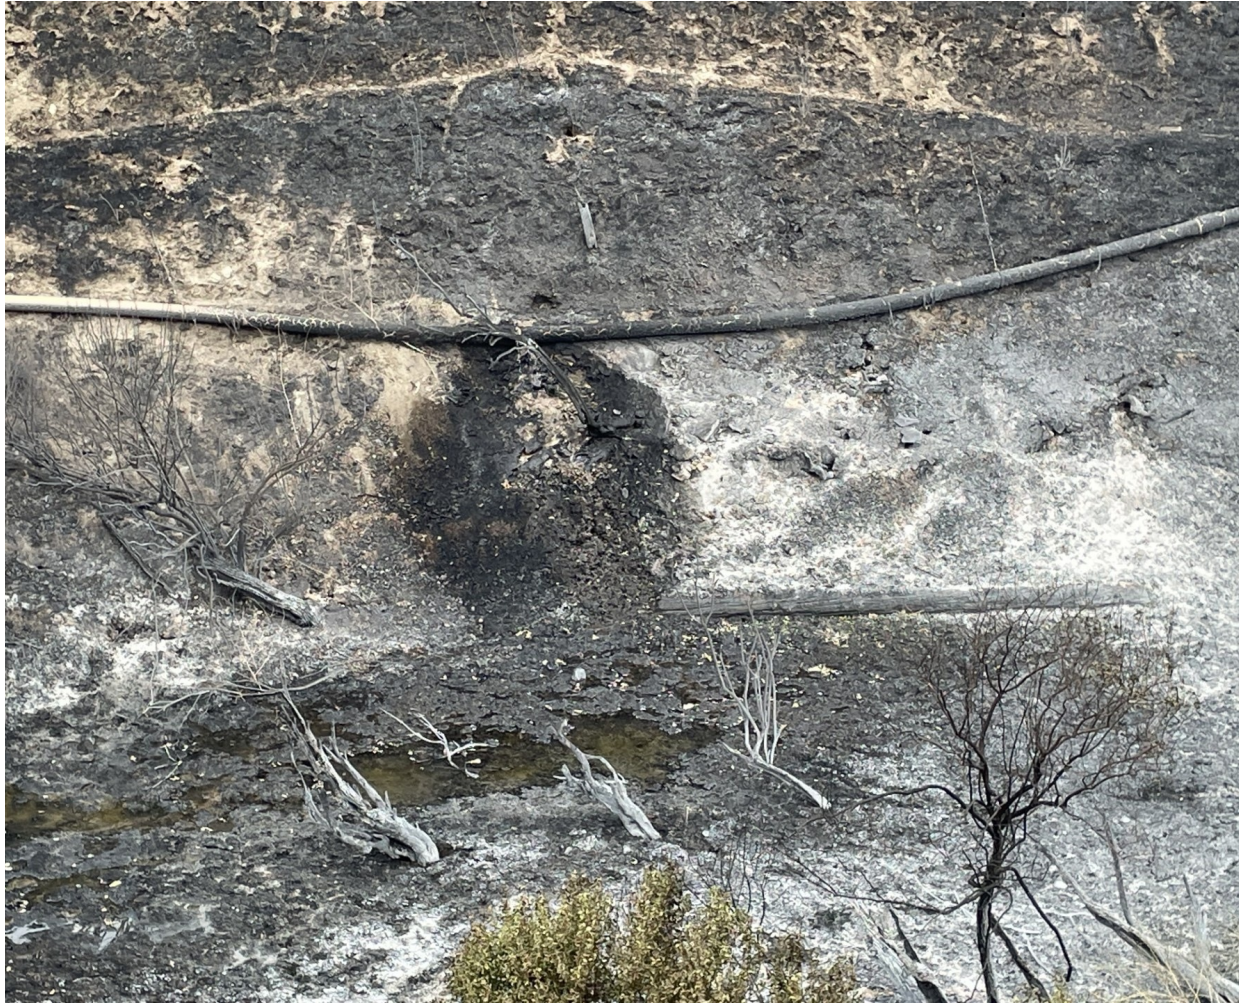
830-DISS GWTS influent pipeline.

830-DISS GWTS has significant damage.

Approximately 6,000 gal of untreated groundwater was released from this pipeline during the fire.

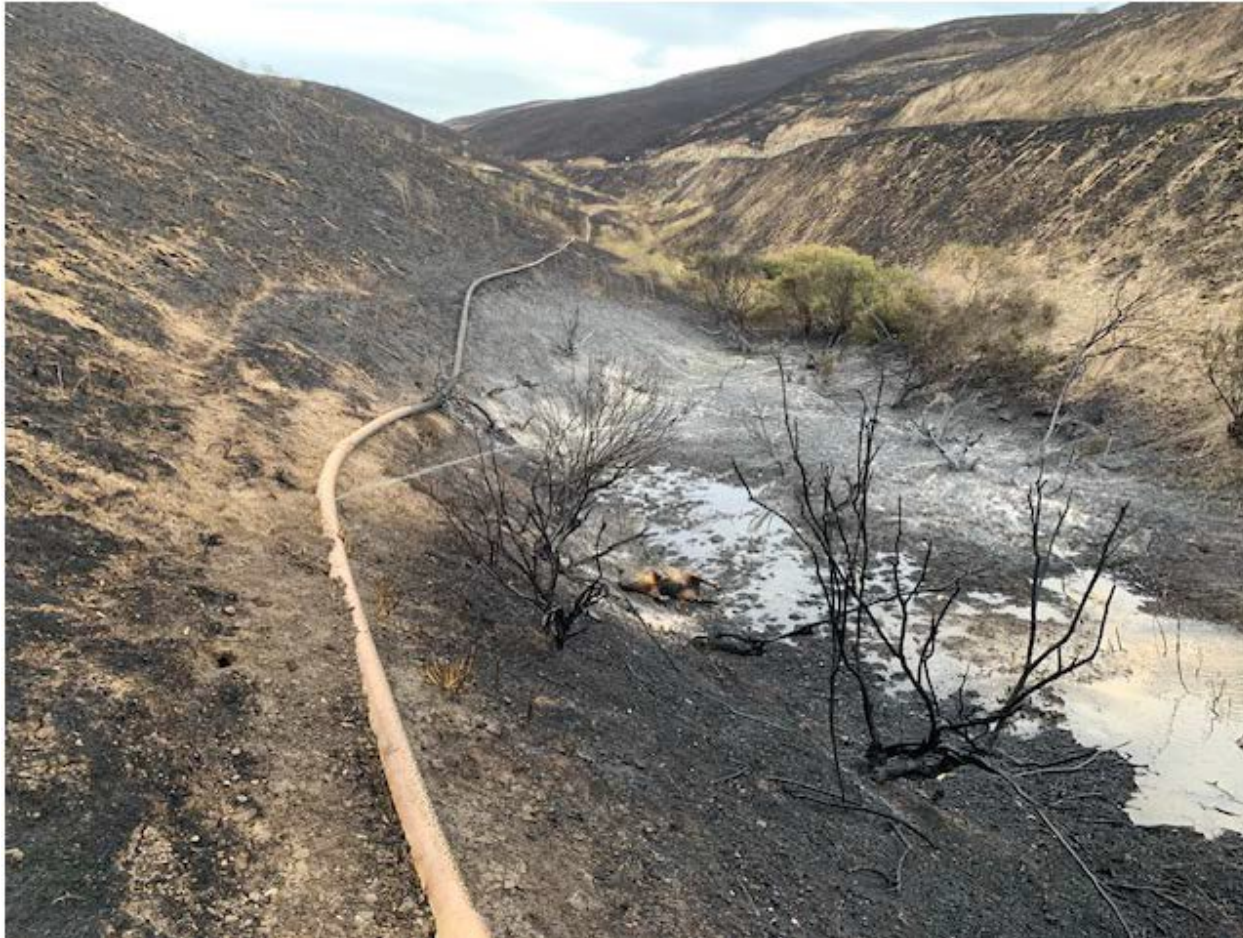
830-DISS GWTS has significant damage.

830-DISS GWTS influent pipeline.

The 830-DISS artesian wells were secured once site access was allowed (Monday, June 3).

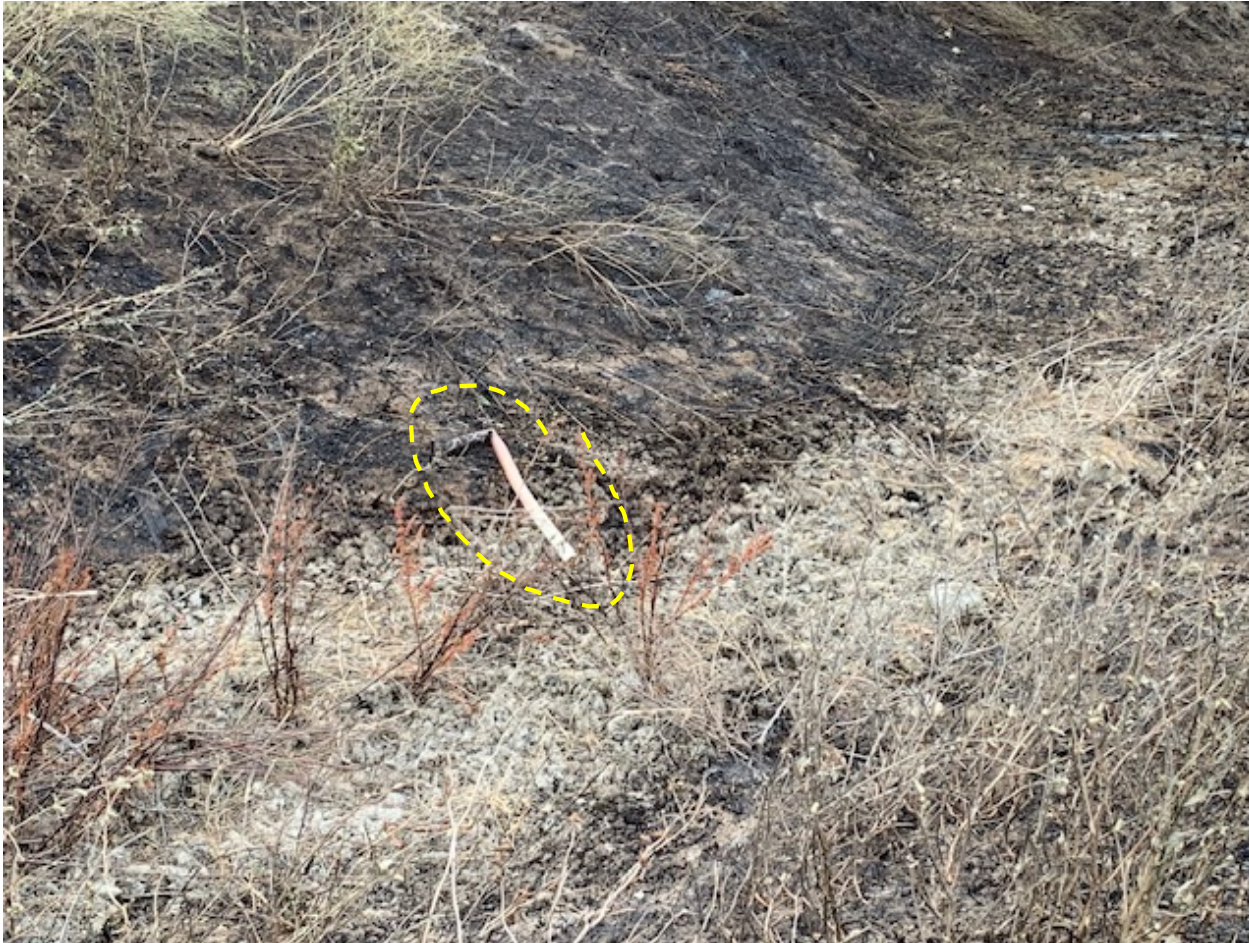
830-DISS GWTS has significant damage.

Several shallow monitor wells completed in the Qal/WBR HSU were damaged.

The 830-DISS artesian wells were secured once site access was allowed (Monday, June 3).

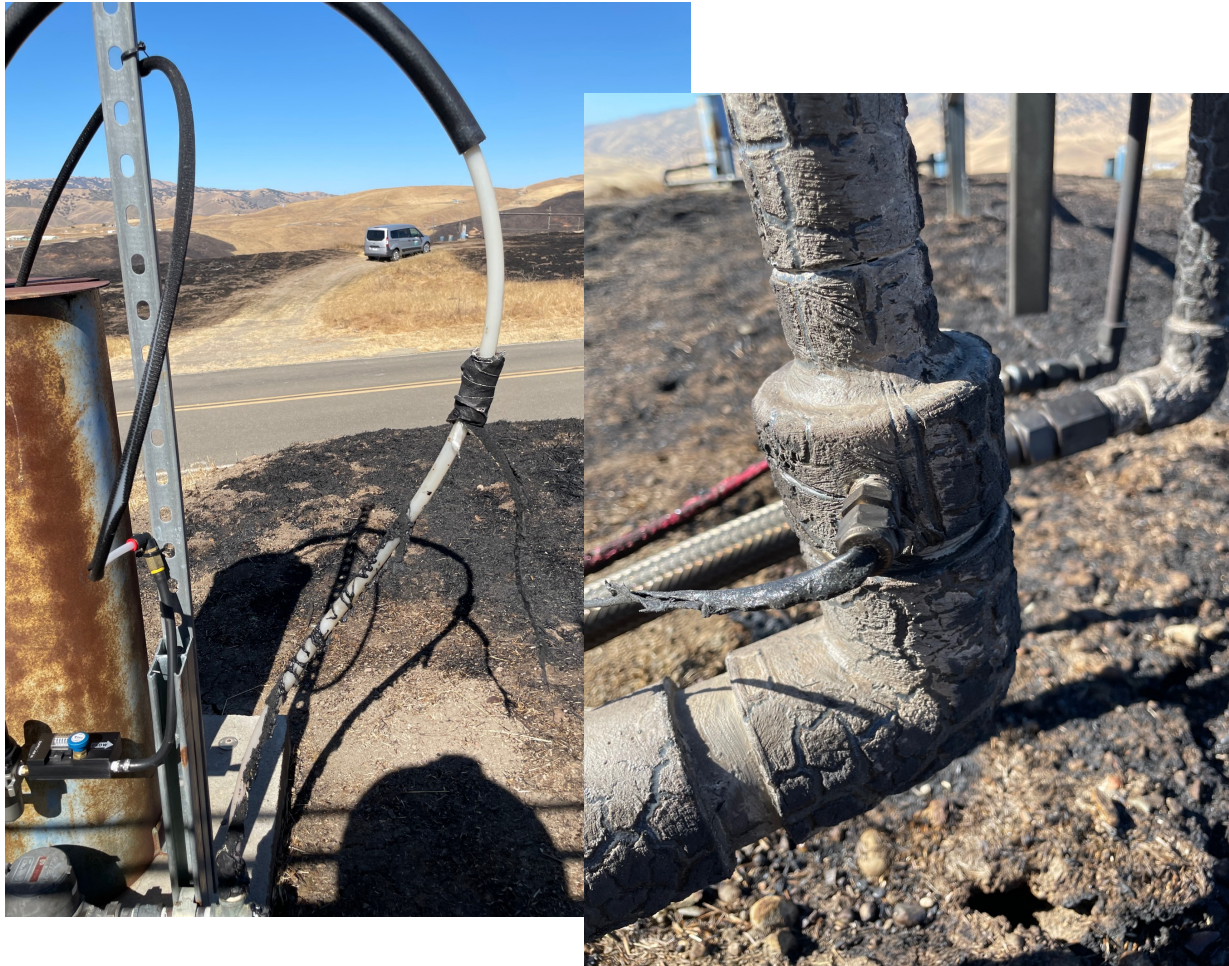
Several 834 GWTS & SVTS wells were damaged.

Significant damage to four extraction wells in the 'leach field' area.

834 GWTS extraction wells W-834-S12A and W-834-2113.

GWTS may be operable, though only on limited wells, once damage to effluent pipes are repaired.

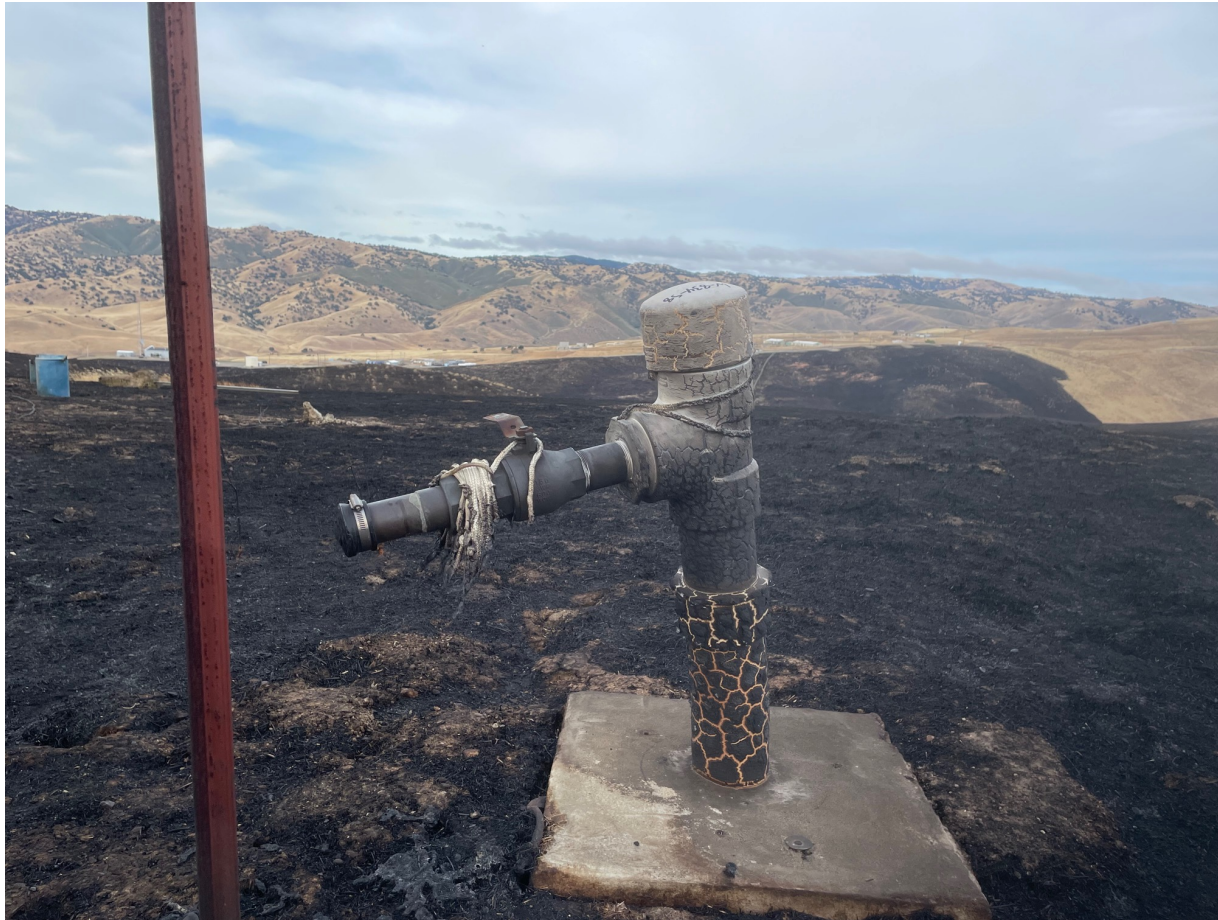
Some 834 GWTS & SVTS wells were damaged.

834 Area monitor well W-834-S8. Significant damage

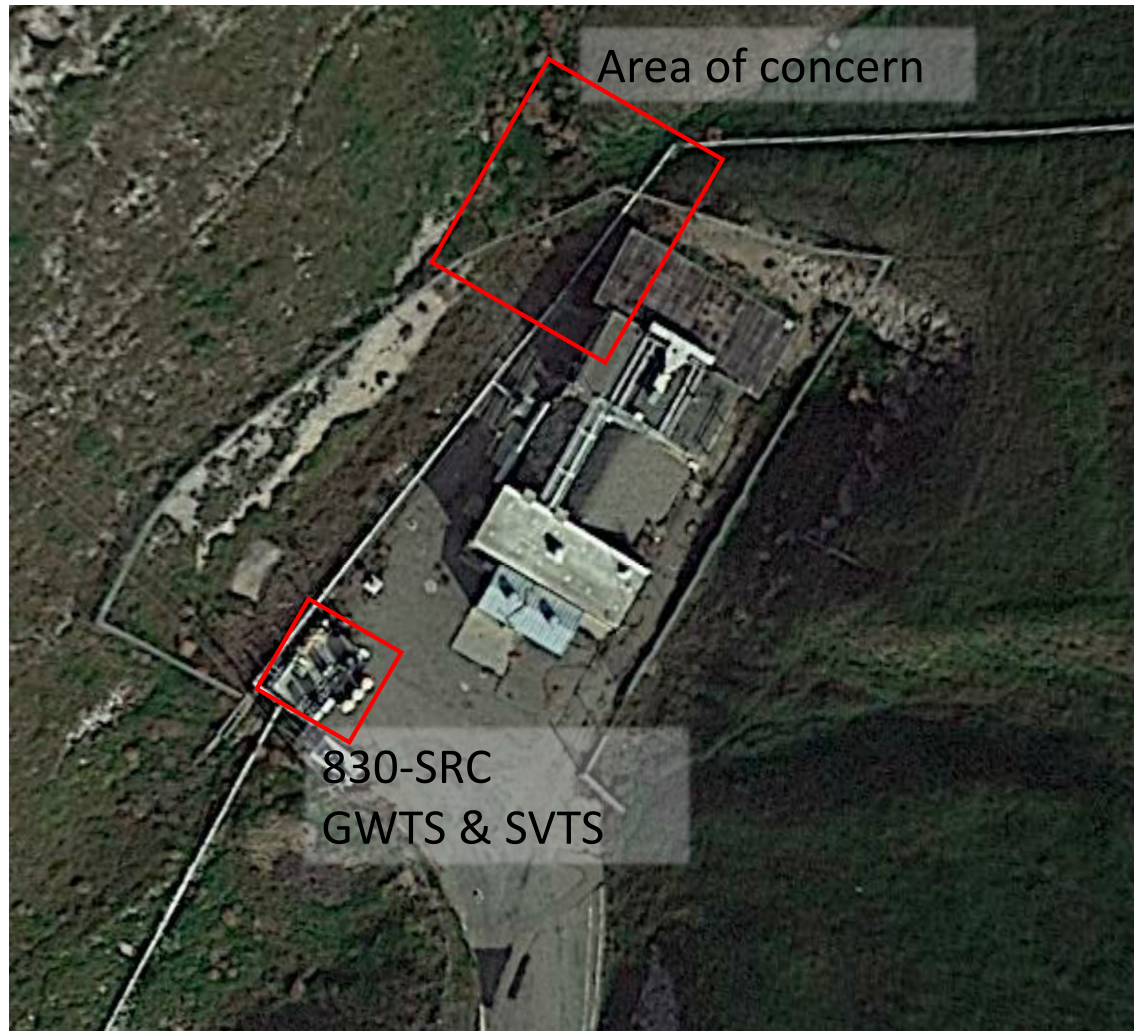
830-SRC GWTS & SVTS wells and pipelines significantly damaged.

The 830 building structure was damaged. The building is not occupied (cold-and-dark).

Building 830 and the 830-SRC treatment facilities.

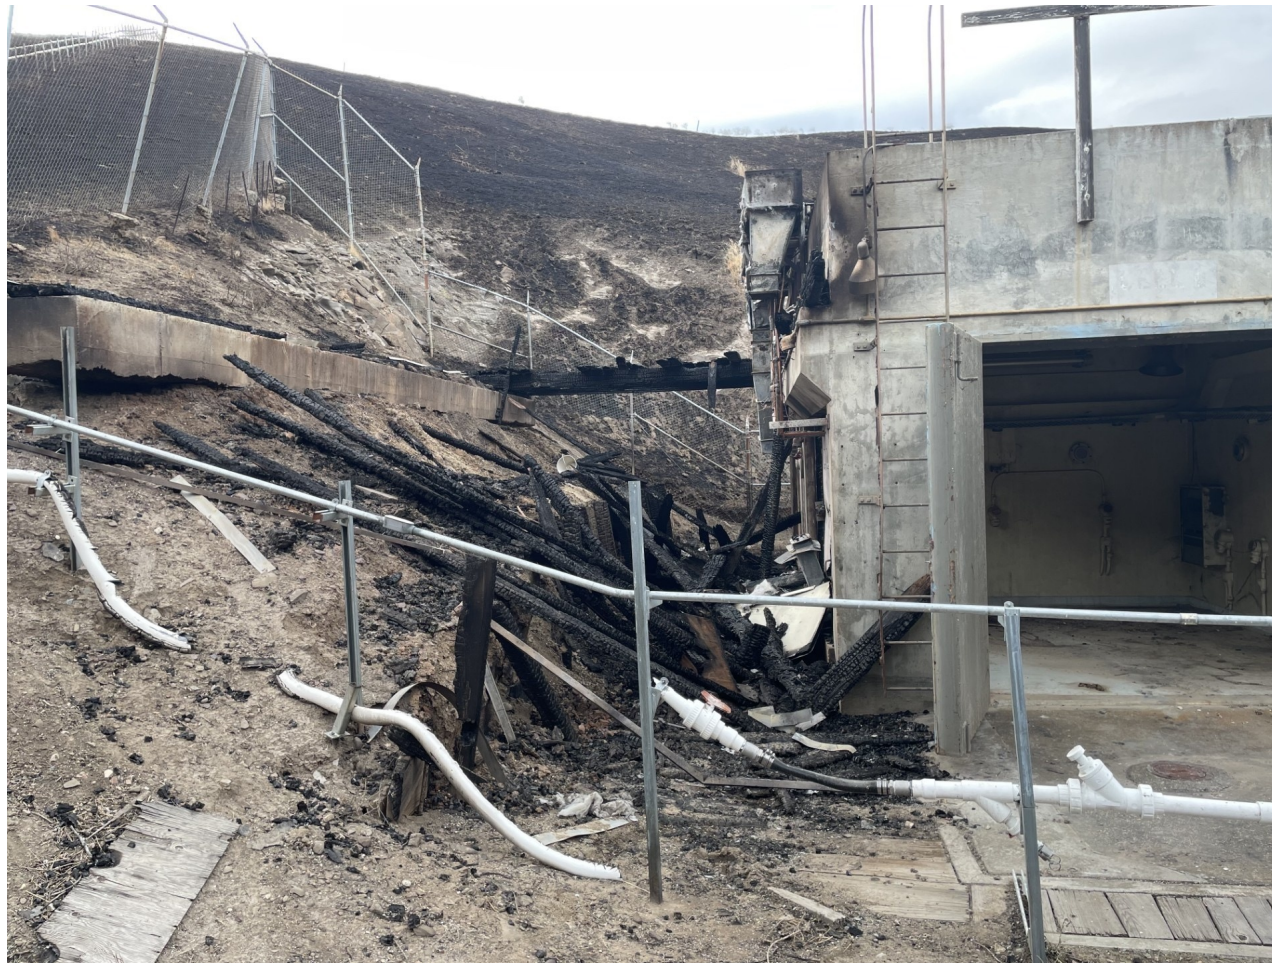
830-SRC GWTS & SVTS wells and pipelines significantly damaged.

The 830 building structure was damaged. The building is not occupied (cold-and-dark).

Building 830 and the 830-SRC GWTS effluent pipeline.

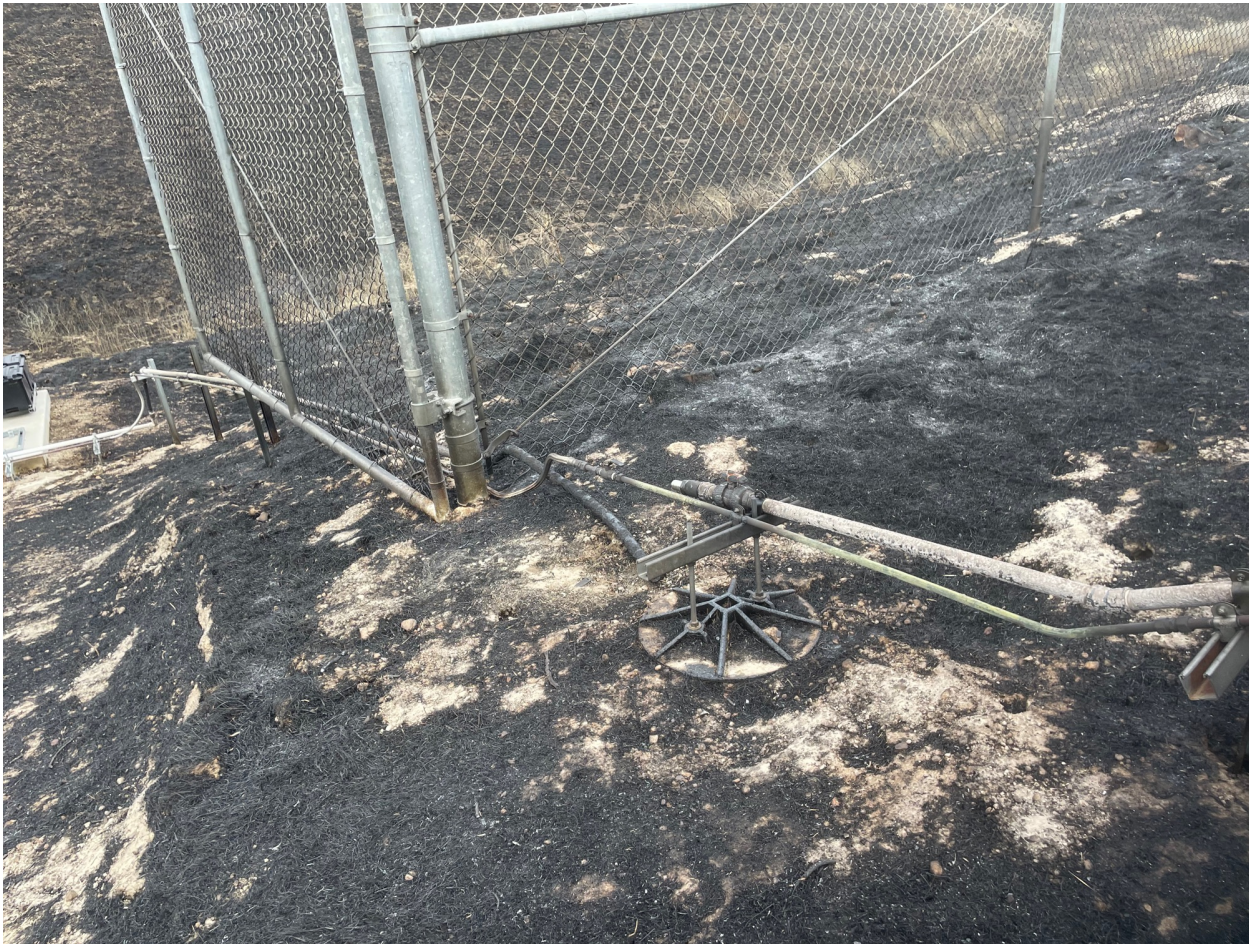
832-SRC GWTS & SVTS wells and pipelines significantly damaged.

832-SRC GWTS pipeline.

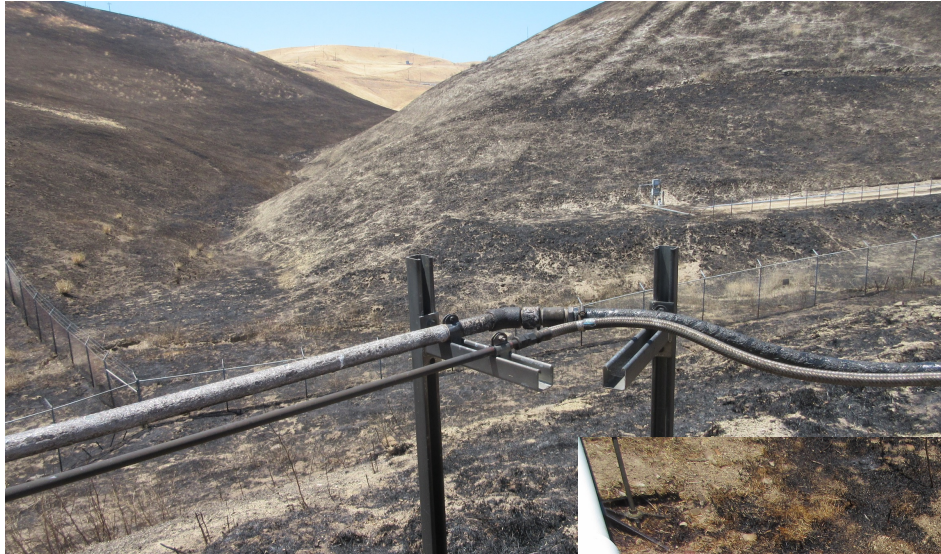
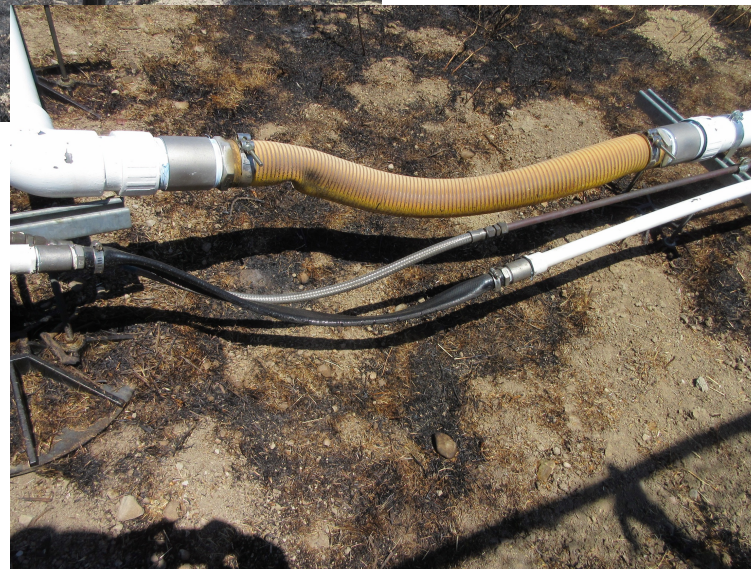
832-SRC GWTS & SVTS wells and pipelines significantly damaged.

832-SRC GWTS pipeline.

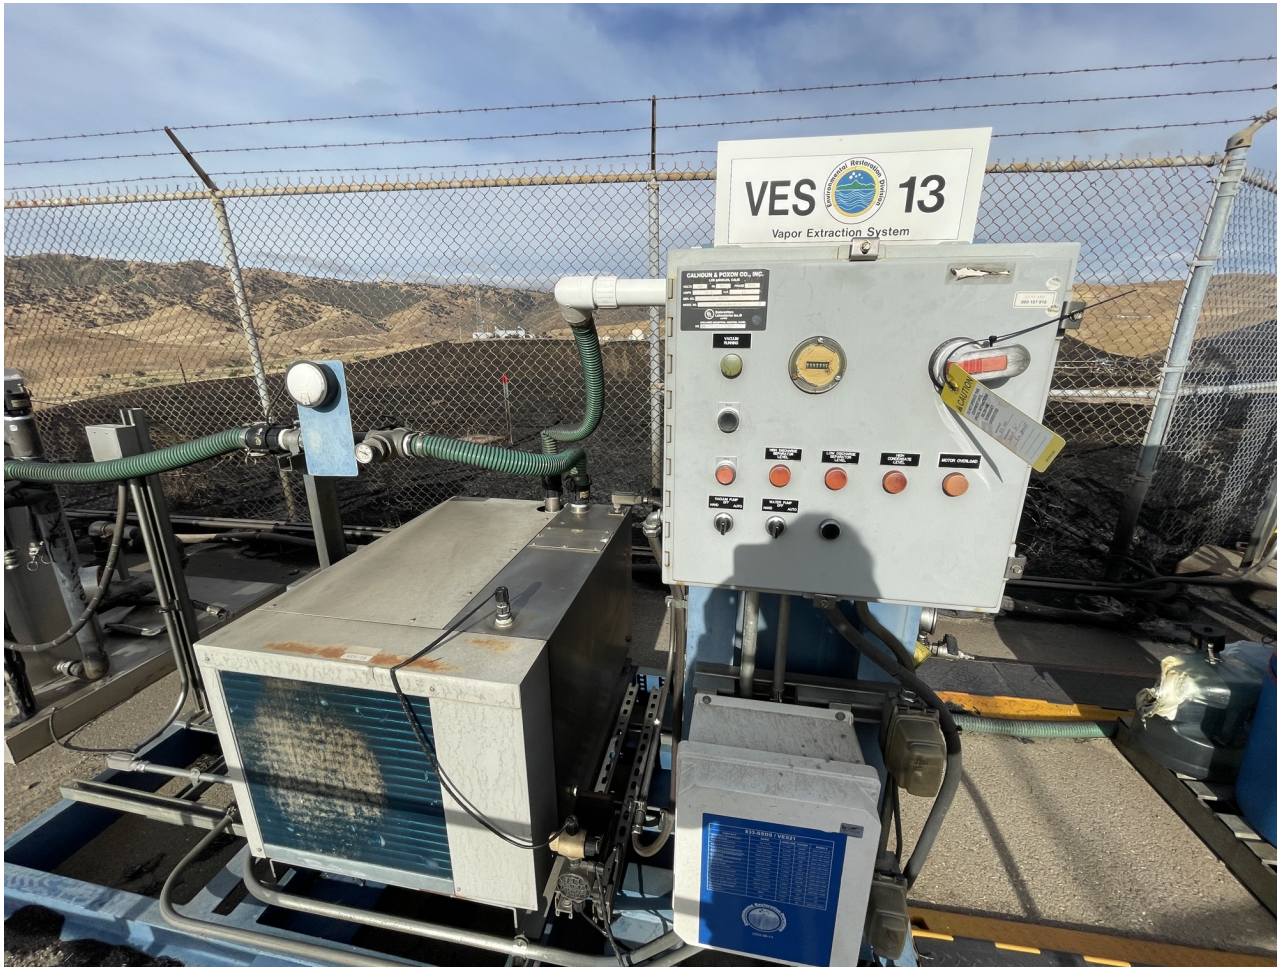
VES13 was a skid-mounted system that was deployed in 2018 in response to elevated TCE concentration in indoor air (Bldg. 833), is significantly damaged.

833-SSDS (sub-slab depressurization system) engineering control system.

A permanent system (VES21) is scheduled to come on-line this year. It was not damaged.

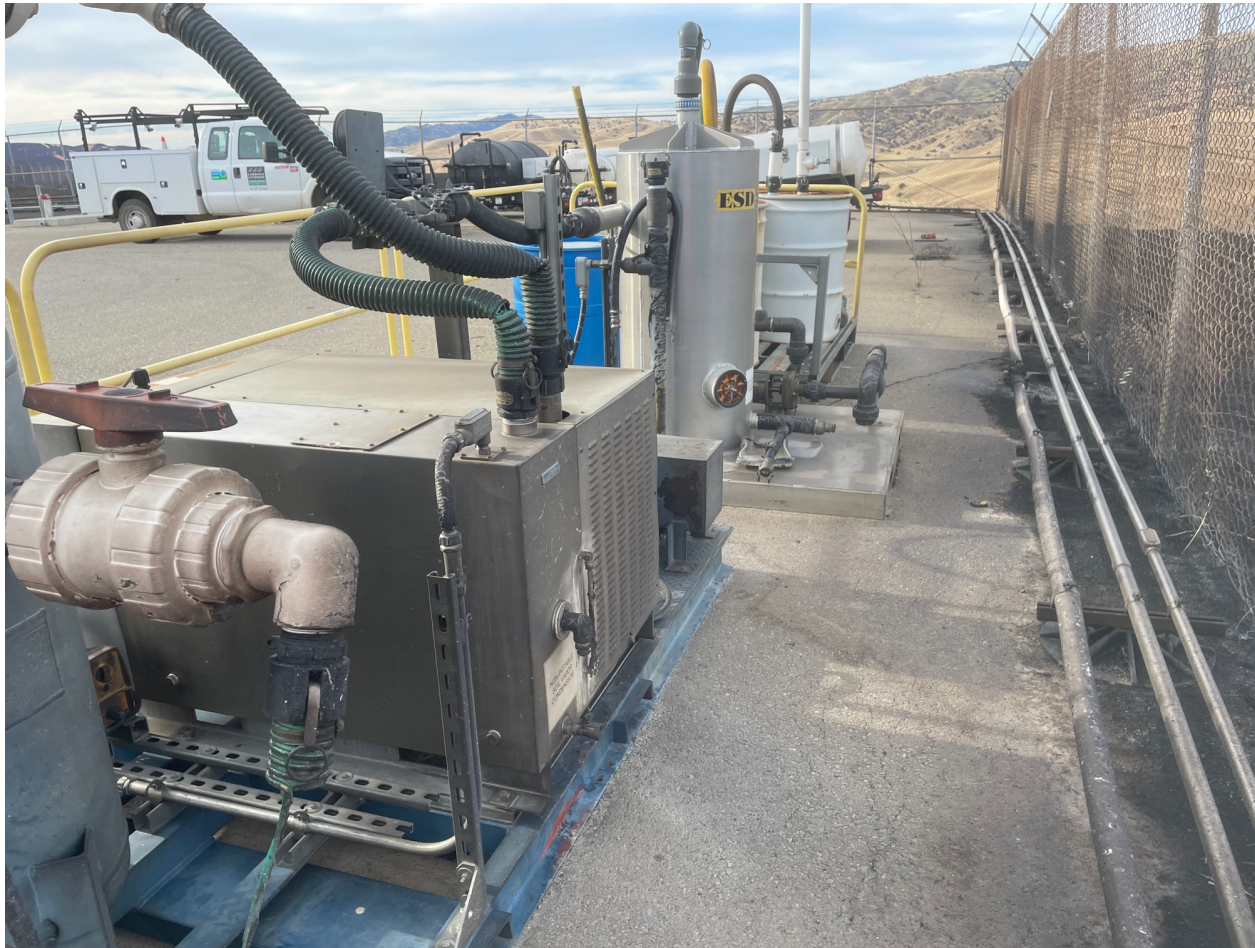
VES13 was a skid-mounted system that was deployed in 2018 in response to elevated TCE concentration in indoor air (Bldg. 833), is significantly damaged.

833-SSDS (sub-slab depressurization system) engineering control system.

A permanent system (VES21) is scheduled to come on-line this year. It was not damaged.

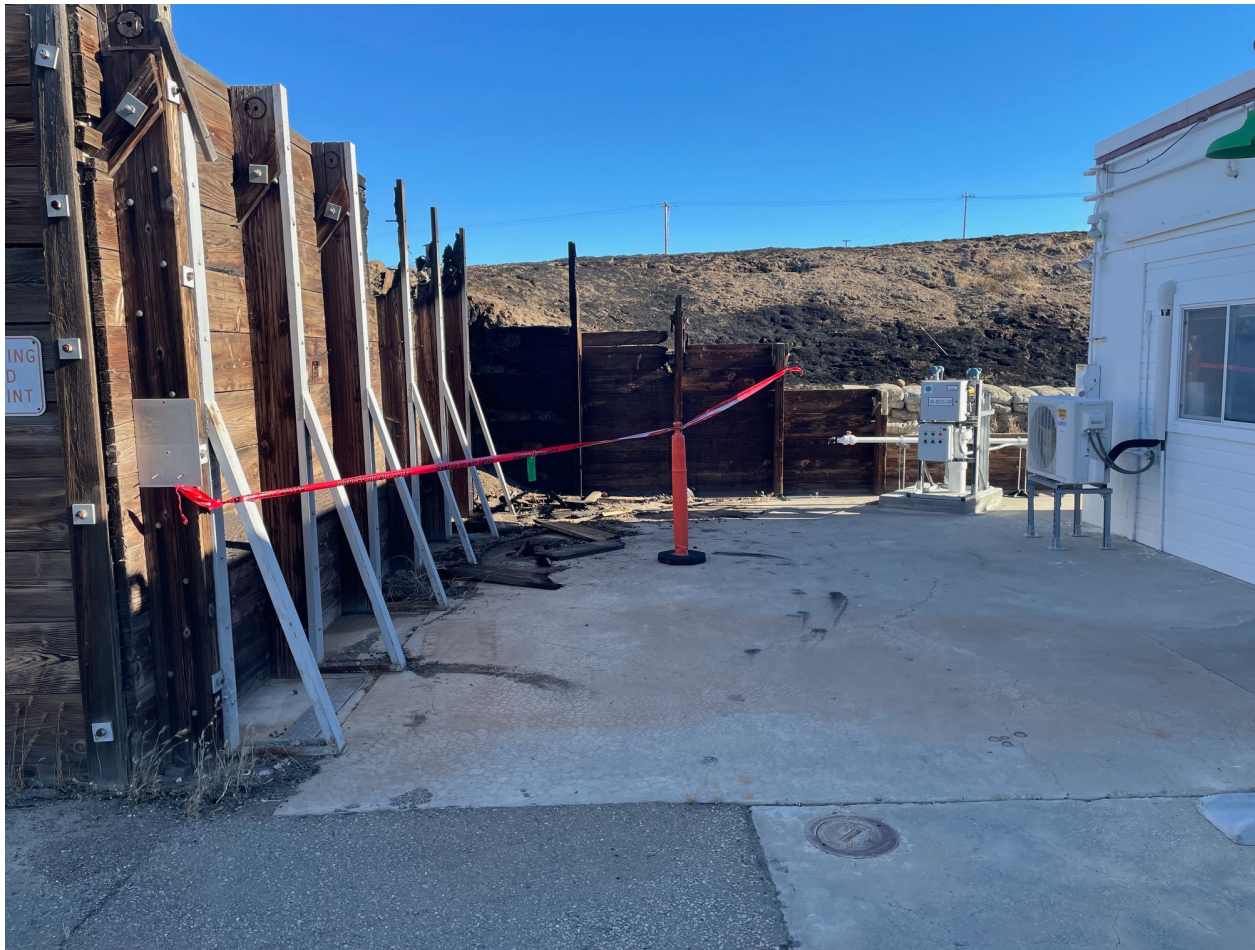
VES13 was a skid-mounted system that was deployed in 2018 in response to elevated TCE concentration in indoor air (Bldg. 833), is significantly damaged.

Retaining wall damage near the vapor recovery well W-833-34.
