Root Cause Analysis of the June 1, 2024, Corral Fire that Disrupted Operations at LLNL's Site 300

Lawrence Livermore National Laboratory,
P.O. Box 808, Livermore, CA 94551-0808

September 6, 2024

Title: Corral Fire Disrupts Operations at Site 300

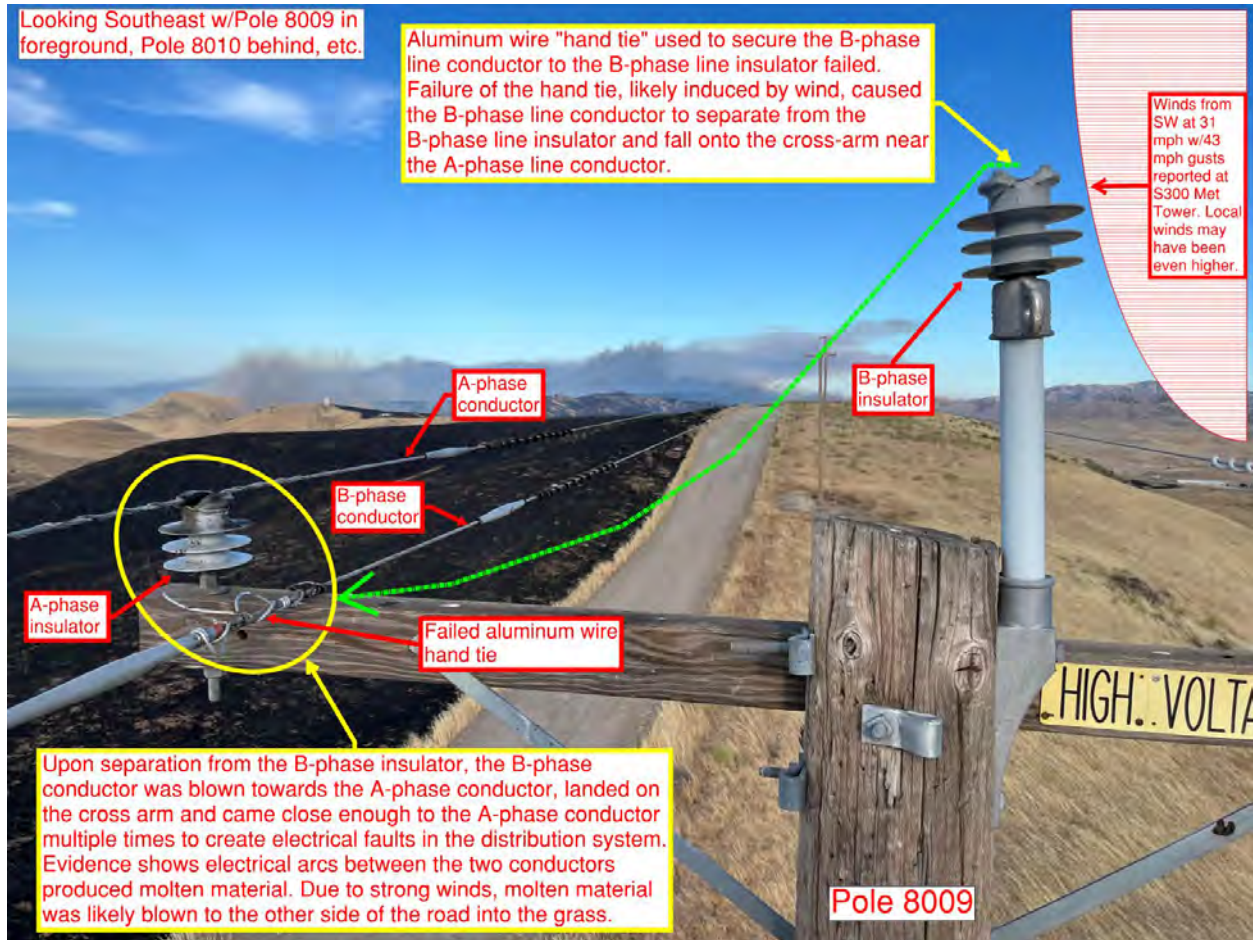
Figure 11. Condition of Pole 8009 on June 1, 2024, after the Fire Initiated (A- and B-phase lines in close proximity)

Figure 12 shows the state of distribution pole 8009 on June 1, 2024, after the fire had initiated, with the B-phase line resting within what appears to be inches away from the A-phase line, no longer attached to its insulator. It is known that the B-phase line hand tie failed, as remaining parts of it were still attached to the conductor and can be seen in Figures 13 - 15. Based on the evidence of pits where melting occurred, deposits of molten material, and charring on the parts that are left over (Figures 13 -15 below), when the hand tie failed on the B-phase line conductor, the B-phase line was able to come in contact, multiple times, with the A-phase line's conductor. This contact is believed to have caused sparks to fly and land on the east side of pole 8009 (across the fire trail), igniting the grass. Figure 12 shows the B-phase line close to and almost touching the A-phase line insulator. The A-phase line's (roadside line) insulator was damaged, along with portions of the A- and B-phase lines and their associated vibration dampers. The C-phase line was untouched (on the west side of line B), along with its insulator and vibration damper. The insulator for the B-phase line was also undamaged.

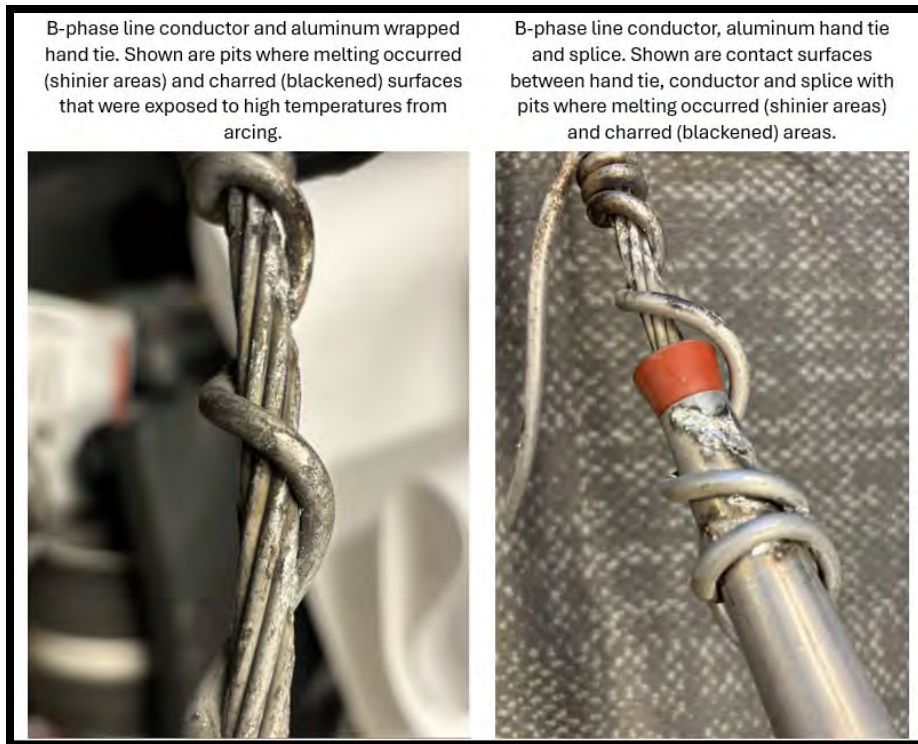
Figure 12. Damage to Pole 8009's B-phase Line Equipment

Pole 8009 did not break in this event. No structural damage was observed to any of the above items of equipment, except for the aluminum hand tie that failed on the B-phase line. Some burn marks, likely due to high temperature exposure from electrical arcing of conductors, were observed on the A-phase insulator. Similar marks were observed on the A- and B-phase conductors, in addition to pits where melting of the conductors occurred.

8:39 p.m.	<p>EUD lineman repaired equipment and the A- and B-phase conductors on pole 8009. Due to conductor damage from arcing, the A- and B-phase conductors were replaced where the damage occurred (damage centered at pole 8009). Both A- and B-phase conductors were cut, new sections installed and spliced, using bump sleeves, to connect to the existing conductors. Finally, the conductors were secured to the existing B-phase insulator with a F-neck and the A-phase insulator was replaced and the A-phase conductor secured with a F-neck to the insulator.</p> <p>EUD lineman performed a visual inspection of all 478 distribution poles at S300; no issues were found.</p>

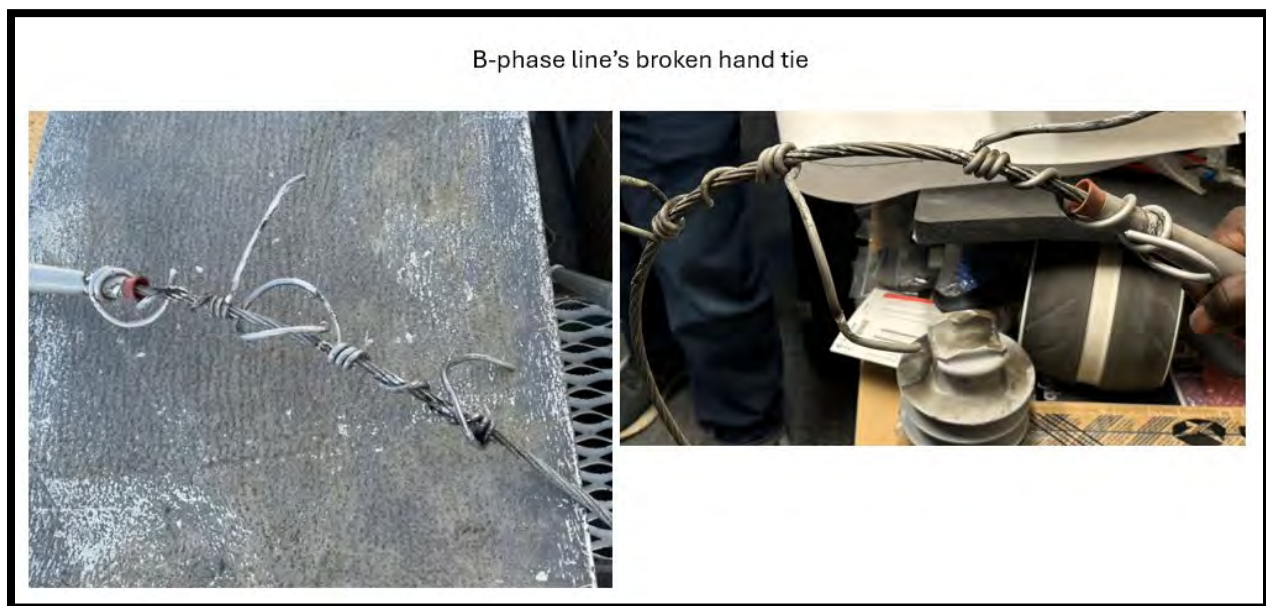
Figure 14. B-phase Line's Failed Hand Tie

An EUD lineman identified that the fire ignited around pole 8009, the 9th pole in Feeder 8 at S300. The lineman observed that an aluminum hand tie on the B-phase line (i.e., middle conductor) atop pole 8009 had failed, causing the conductor to no longer be held to the insulator, the direct cause. The failed hand tie allowed the A- and B-phase lines to make contact with one another. It is suspected the contact between lines A & B caused arcing resulting in sparks that ignited the surrounding grassland. The exact reason for the hand tie failure remains unknown, but high winds were determined to be a likely factor. Feeder 8, one of two feeders running north to south on the tallest ridgeline of S300, tends to experience the highest winds.

- The hand tie holding the B-phase line to the insulator failed on pole 8009 [Direct Cause]. Note that the hand tie is a common type of fastening used by LLNL and other utility companies in similar applications and approved for use under applicable codes.
- Other fastening methods, the F-neck and vise clamp designs were not installed on the B-phase line of pole 8009.
- Additional controls to protect electrical utilities against high winds have not been implemented at S300. Additional controls include, but are not limited to, turning reclosers off during extreme wind, relocating feeder, moving feeder 8 electrical utilities underground, insulating feeder 8 conductors, and/or implementing PSPS at S300.

- **Proper tying method of the hand tie** – It is unknown if the hand tie was or was not tied properly to the insulator. There is no evidence, however, that when the hand tie was installed, the tie overlapped itself around the insulator. An overlap of the tie material can become a wear point due to abrasion, as stated in installation procedures, creating a potential weak point. This seems unlikely, as the equipment on the cross arm was subject to routine maintenance in October 2023, when any abnormality from prior installation would have been identified and addressed. Based on what is left of the hand tie, the remaining portion appears to have the appropriate number of buttons on either side of the insulator (See Figure 4 for a visual description of a button).

LLNL had a plan to replace hand-ties with steel F-neck fastenings over time and started implementing that plan prior to 2014. As of July 26, 2024, only eight poles with hand ties were left to replace at S300, which includes at most 24 hand ties, three per pole. All hand ties have been replaced at Site 200 (S200). The absence of any history of this failure mode of securing the conductor to the insulators, combined with the fact that hand ties are an industry standard method, also indicated that the plan to replace fastenings over time was reasonable.
