Incident Analysis (IA)/Root Cause Analysis

Release of Combustion (and Contamination) Products after an Experiment at the Contained Firing Facility (CFF)

NA—LSO-LLNL-LLNL-2021-0019

October 21, 2021

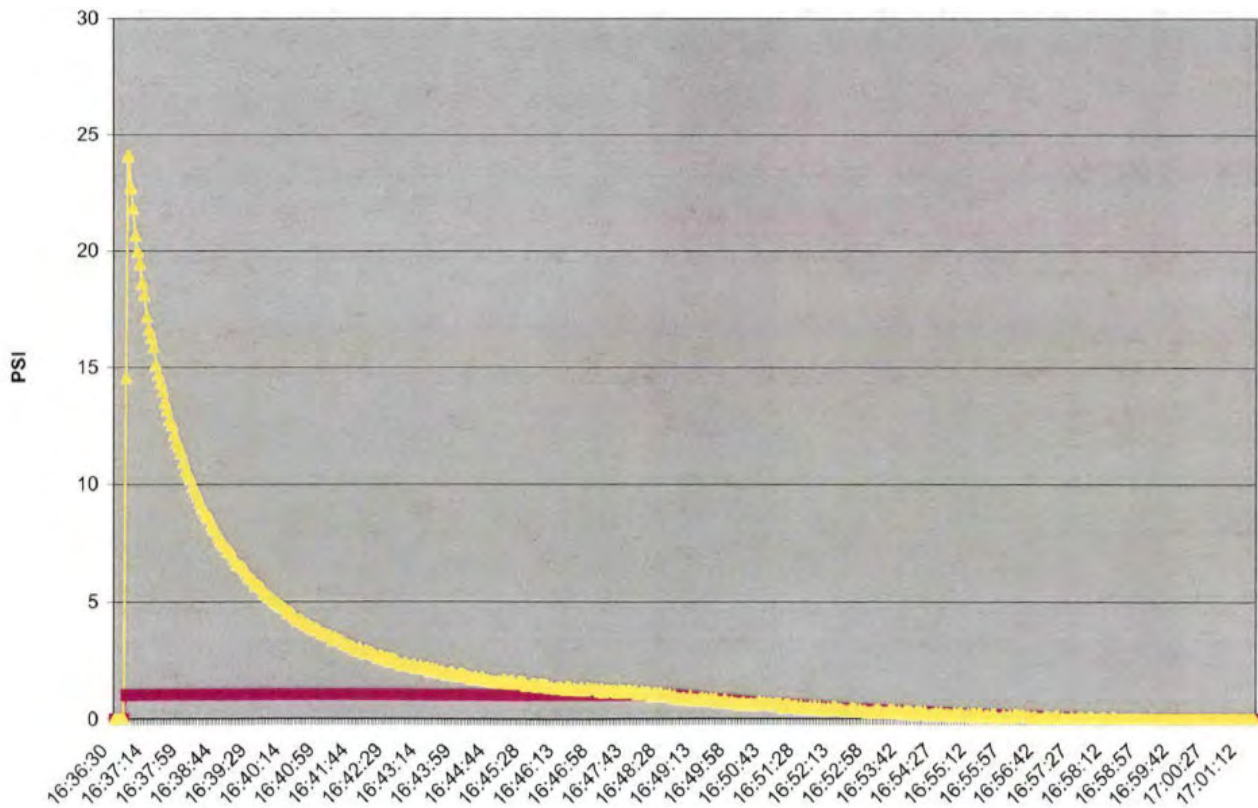
Figure A6: Chamber pressure history for a CFF experiment performed 6/20/2002.

Unless v_2 and v_3 are small compared to v_1 , the pressure will peak well below the maximum. The observed time history, as qualitative as it is, places constraints on these rates. Additionally, there is pressure-time history data from some of the early CFF experiments that constrains the chamber cooling rate, v_3 . Figure A6 shows a chart record for chamber pressure from the first shot in Table A1.

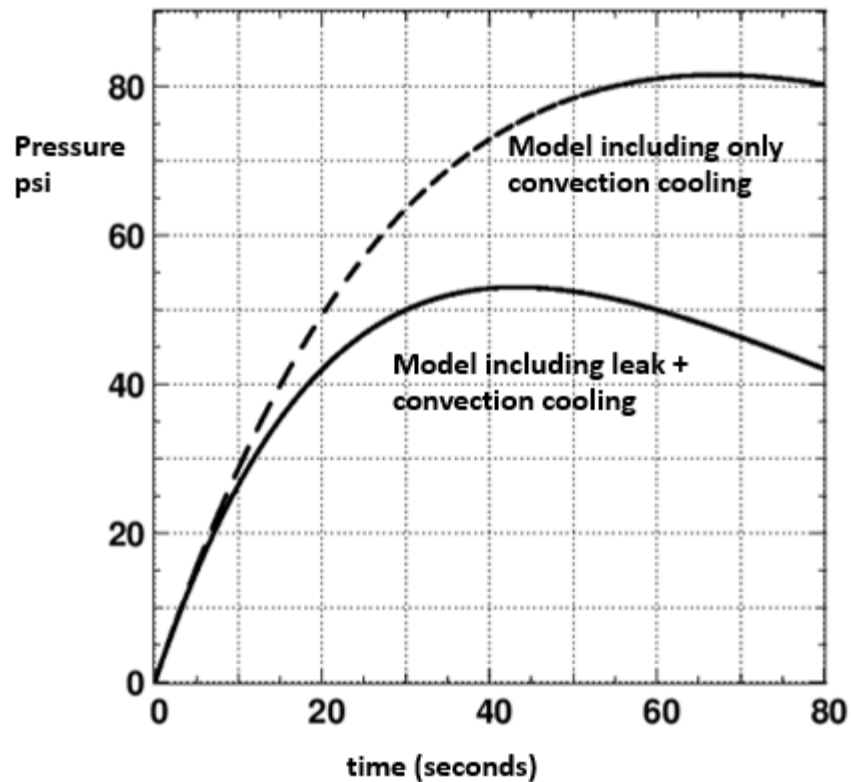
Figure A7: Models of chamber pressure versus time.

with the corresponding pressure/time history from equation A8 shown as the lower curve in Figure A7. A key point is that the pressure dropping below 50 psi in 60 seconds forces the solution to reach pressures only modestly above the maximum gauge pressure as opposed to approaching the theoretical maximum of 170 psi. Another interesting point is that if the leak term is neglected, as shown in the upper curve in Figure A7, the decay rate due to convection alone is too slow to bring the pressure below 50 psi at 60 seconds. This suggests that leakage from the chamber was a significant player in limiting pressure rise.

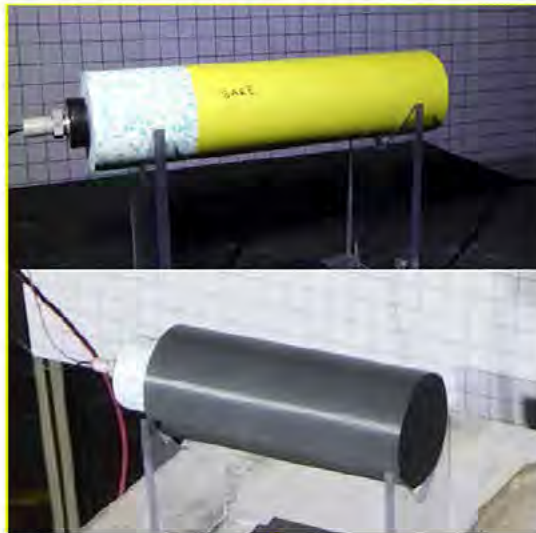
Figure B4: Top: Experimental setup for detonation shock-pulverization of ABS experiment and the control experiment. Bottom: Images of actual setups for control and shock pulverization experiment.

all explosive interfaces were bonded with cyanoacrylate adhesive (Eastman (Permabond™) 910) and allowed to fully cure. The RP-1 detonator was threaded into a 3D-printed PMMA adaptor that was also bonded to the end of the LX-10 booster with cyanoacrylate adhesive. The bonding served to hold the parts fixed to one another without additional encasing or tamping mass and to minimize airgaps at interfaces.

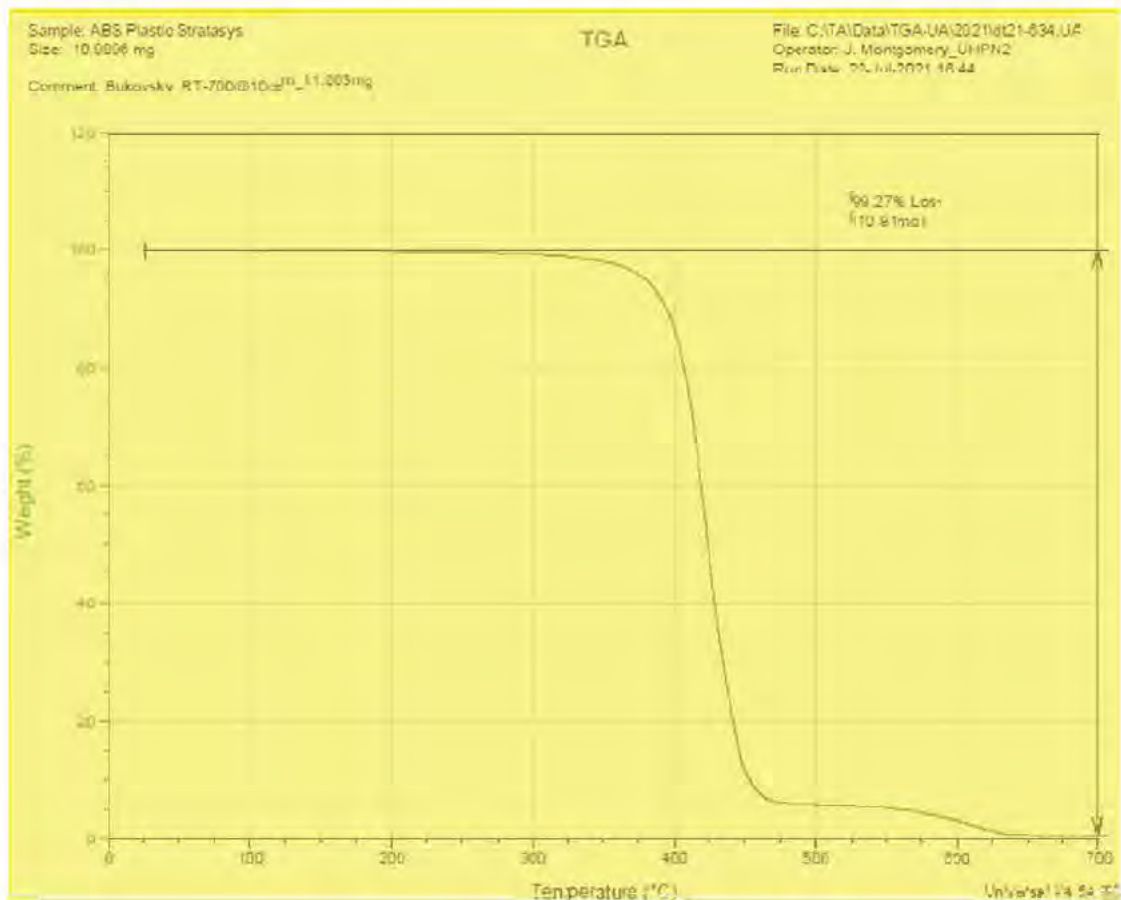
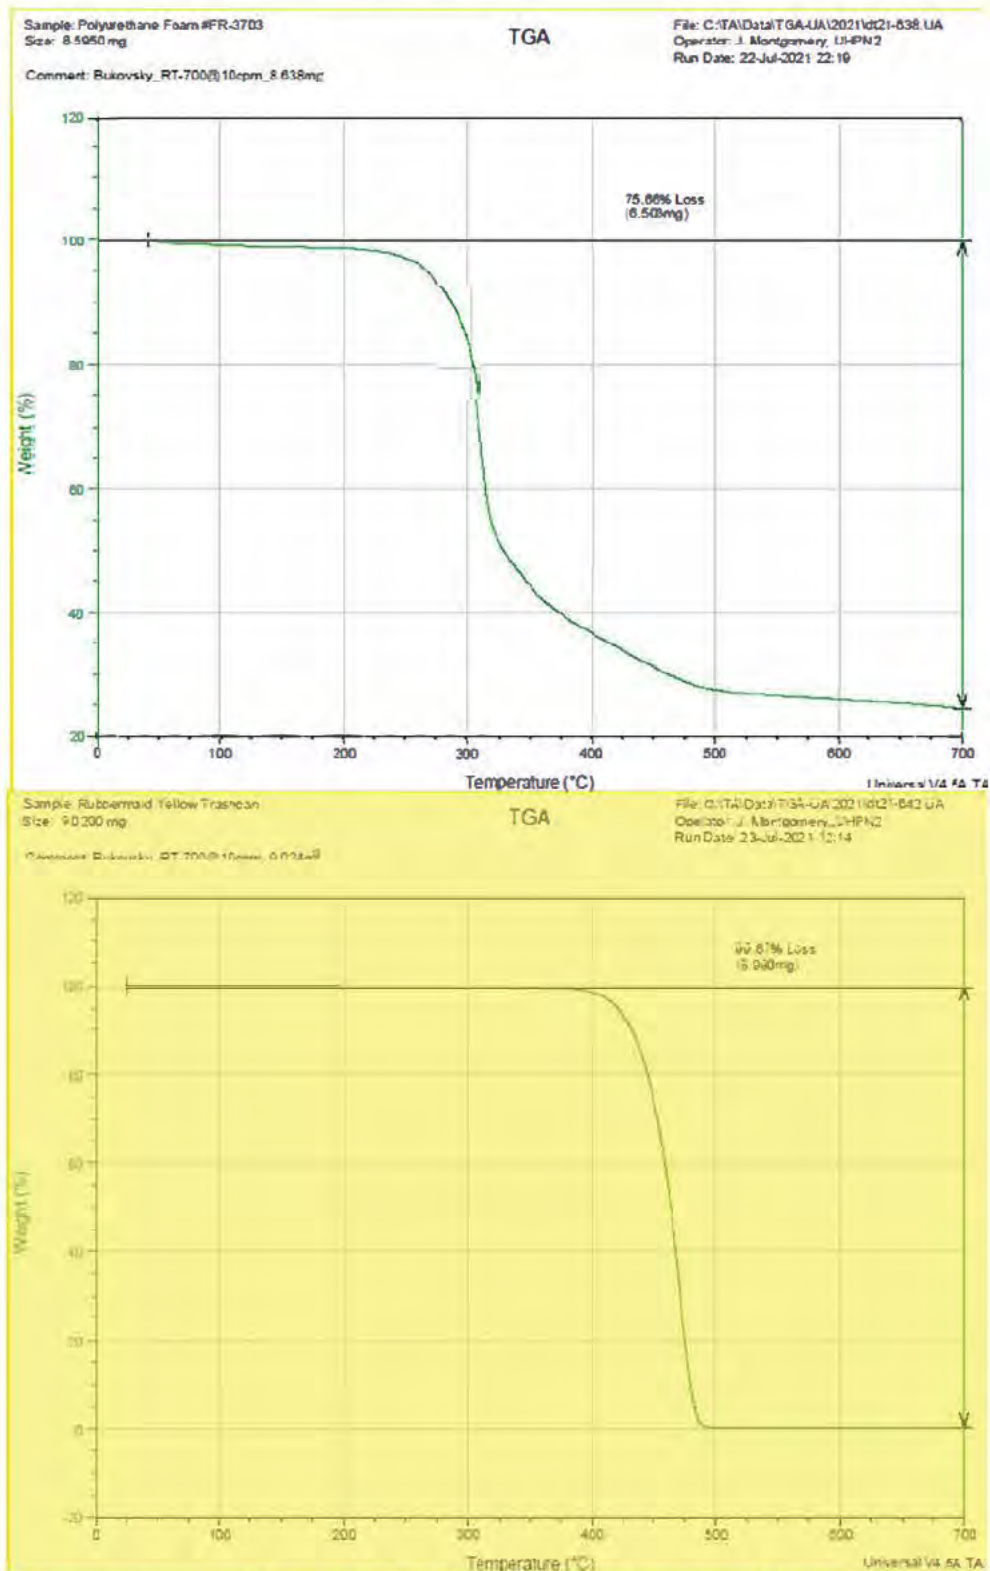
Based on the data listed in Table B1, 3D-printed ABS, the blue foam (polystyrene), and yellow trashcan (LDPE) will decompose with almost no residue when heated to temperatures of 700 °C in the absence of oxygen gas ($O_2(g)$). All three materials rapidly decompose below 500 °C. With all three materials being comprised of organic-based (CHNO) polymers, there is a high likelihood the evolved mass has flammable CHNO fragments and would readily combust at these temperatures in the presence of $O_2(g)$. The FR-3703 and FR-4515 did exhibit lower total mass loss and a reduced mass loss rate during the TGA experiments. Since both FR foams are flame retardant, they did not evolve as much gas as the ABS, blue foam or LDPE, but between the FR foams there were quantifiable differences. The lower density FR-3703 exhibited an average of 13.6% more mass lost than the FR-4515 foam, and the FR-3703 reached 25% mass loss ~ 18 °C earlier than the FR-4515. Finally, the FR-3703 exhibited max mass loss rates that were over double the max mass loss rate of the FR-4515. Thermograms of 3D-printed ABS, FR-3703 and yellow trash can are shown in Figure B8 as examples.

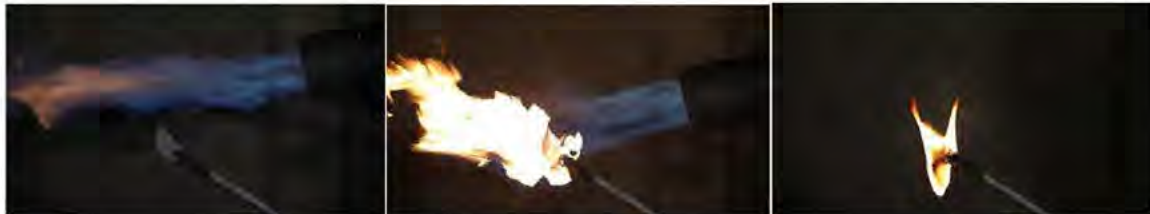
Figure B7: 3D-printed ABS in flame test. Left: prior to exposing the sample to direct flame. Middle: holding flame on sample (note that change in flame color and intensity indicates combustion other than propane). Right: 3D-printed ABS burning to completion after the flame was removed.

The second type of flame heating experiment performed was to expose the sample to the flame until it was ignited and then remove the flame and see if the material continues to burn to completion or self-extinguishes. In these experiments the five materials yielded two basic results: the materials that continued to burn to completion and the ones that self-extinguished. The 3D-printed ABS, control ABS, yellow trashcan, and blue foam all continued to burn until completion after sufficiently burning once the torch was removed. An example of 3D-printed ABS is shown in Figure B7.

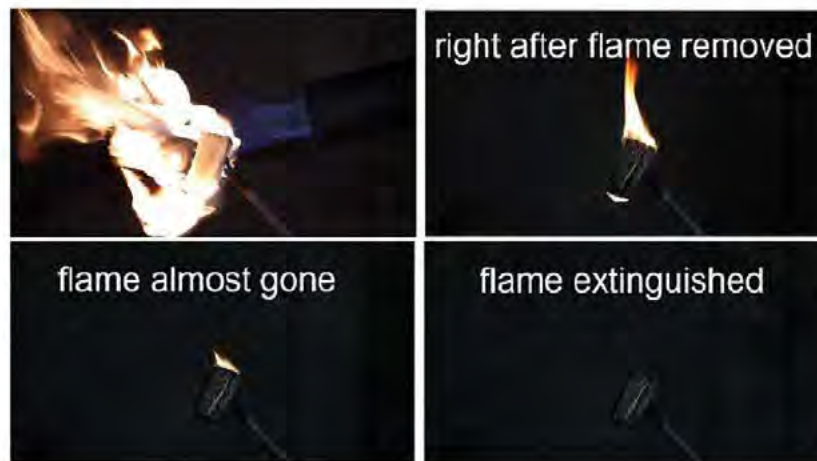
The two different densities of flame-retardant foam exhibited similar results, once the direct flame was removed the remaining flame emanating from the sample quickly diminished and then extinguished. An example of the FR-3703 foam is shown in Figure B10. The FR-3703 foam ignited easier and stayed burning longer than the FR-4515 foam.

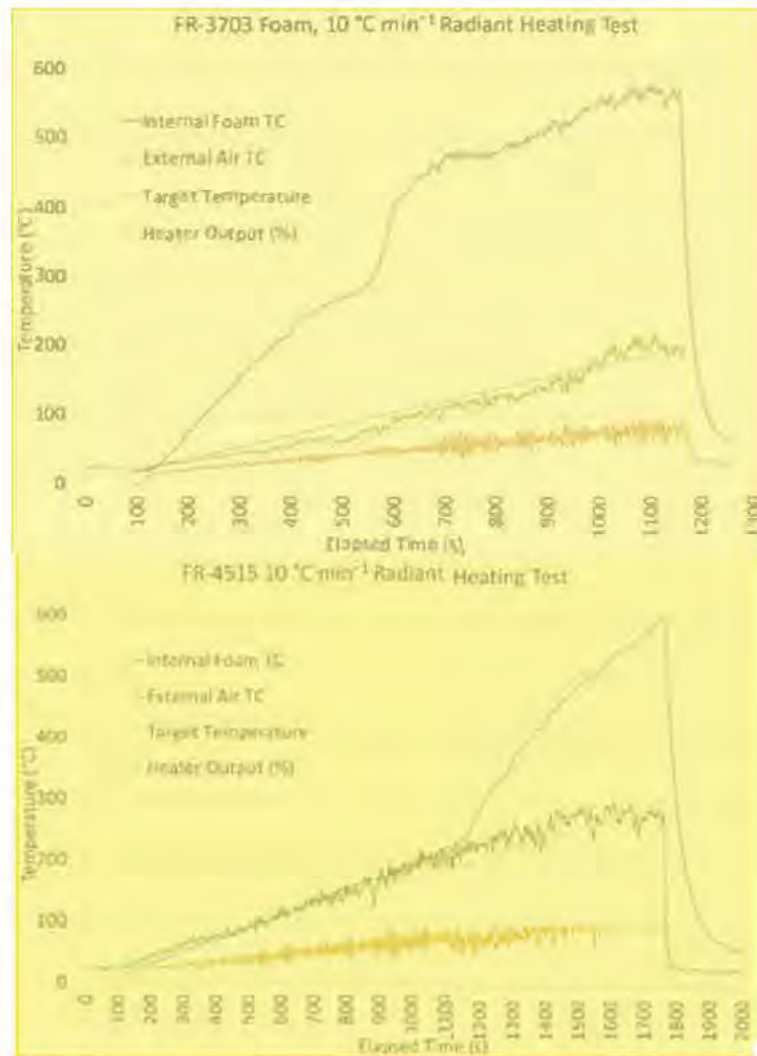
A potential hypothesis to explain this observed result is the following: foams are "generally" intended to slow the transmission of conductive or convective heat by having a low thermal conductivity and low heat capacity. However, the radiant heat can penetrate the foam due to the wavelength of the radiant heat and in doing so transitions from radiant heat to heated mass inside the foam. The foam, effective at resisting conductive and convective heat flow, essentially traps the heat inside, and therefore, the continual incoming radiant heat can continue to heat the inside of the foam samples. This is not observed on the outside as the radiant heat heating the foam surface was being dissipated by air moving over the surface convectively cooling the surface.

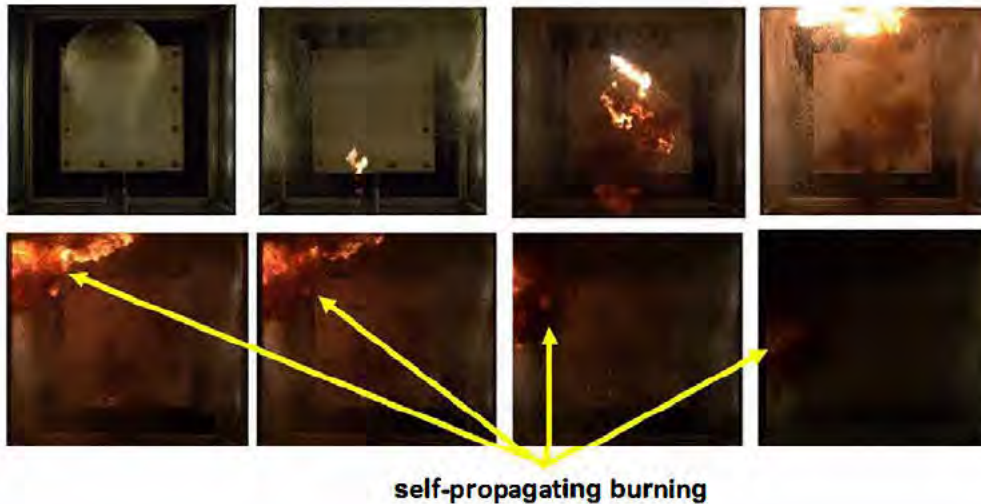
Results from the DFIC of the FR-3703 and FR-4515 foams are shown in Figures B17 and B18 respectively. The FR-3703 foam did show some significant burning after the consumption of the squib, although it did not propagate to fill the test chamber like the fine 3D-printed ABS. The FR-4515 exhibited even less reaction propagation after the squib was consumed. Based on these DFIC experiments, the powdered flame retardant foams likely could have been better optimized to result in a longer reaction propagation, but that would increase the specificity of the conditions for a dust explosion.
