# LLNL Site 300 CERCLA Groundwater Cleanup Project Corral Fire Update

Site 300 CERCLA Remedial Project Managers (RPM) Meeting

June 25, 2024

DOE / LLNL  
Environmental Restoration Department

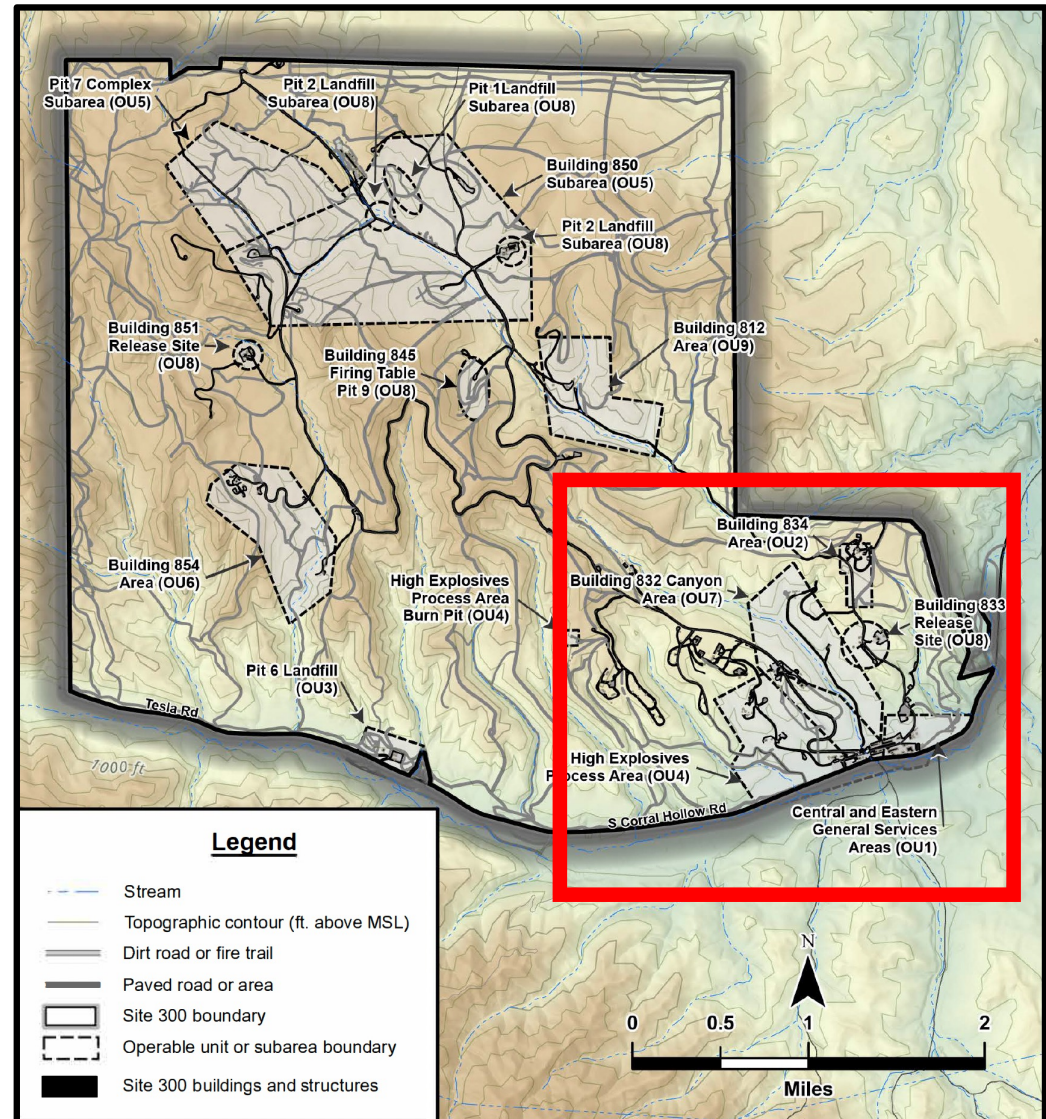
## Summary of damage

The Corral Fire started on Saturday June 1, 2024, near Bldg. 892 and quickly spread across the SE corner of Site 300.

All ten (10) pump-and-treat systems in OUs 1, 2, and 7 were damaged.

833-SSDS (OU 8) was also damaged.

21, out of 130 monitor wells in the impacted area are damaged.

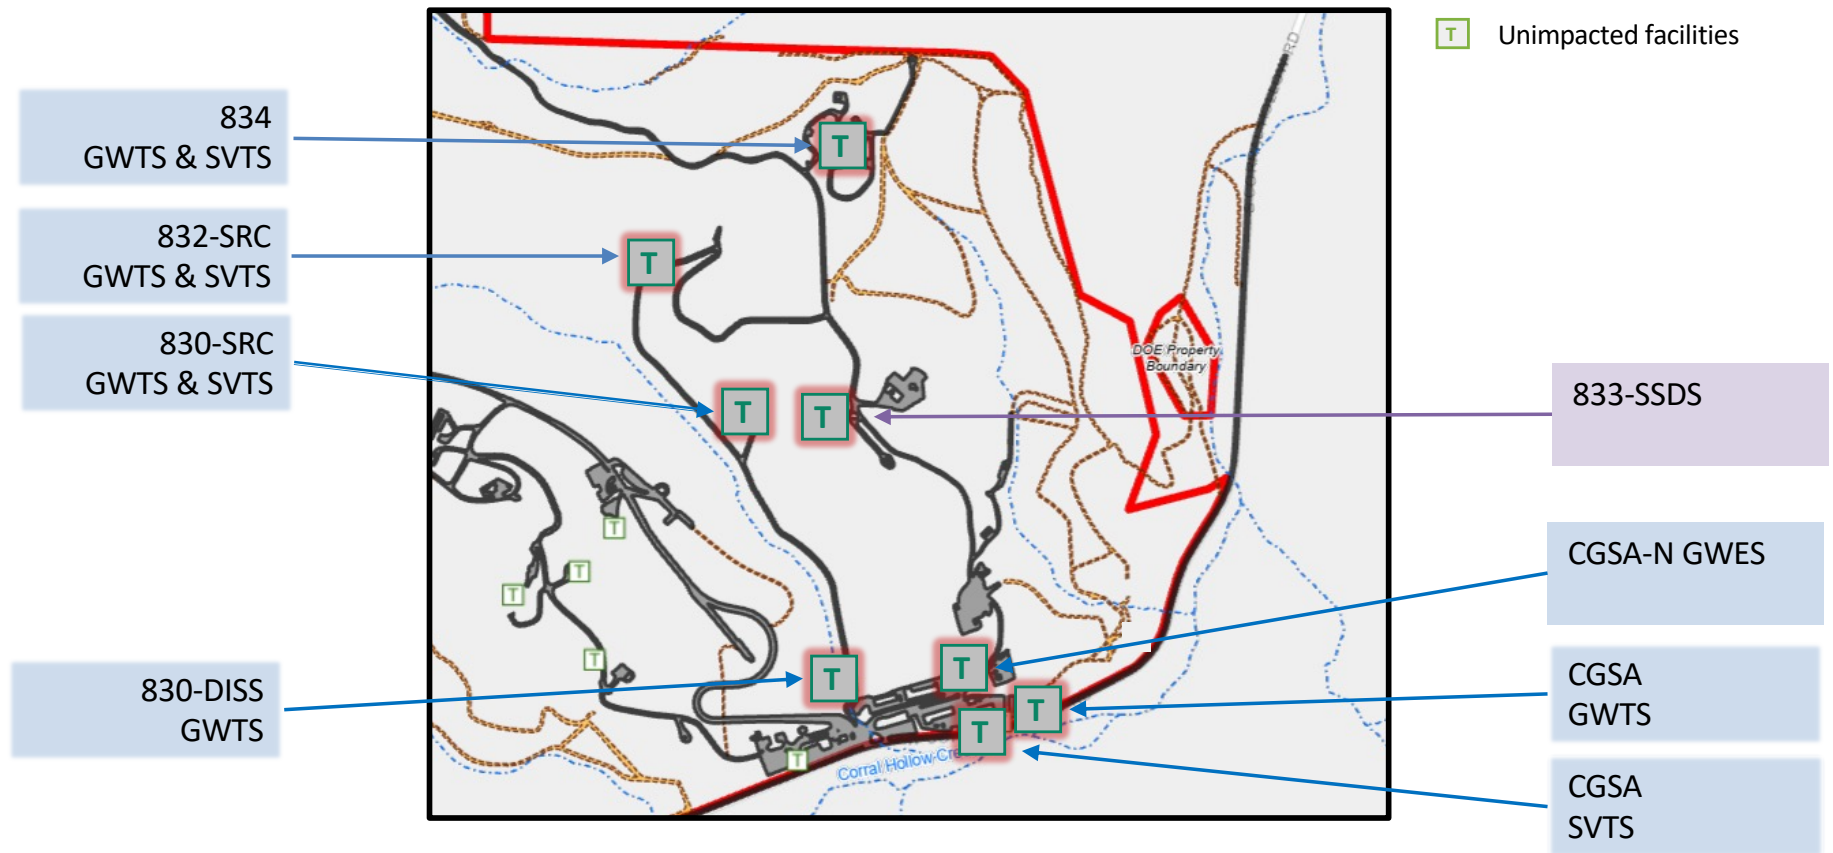
Facilities impacted by Corral Fire
-

Unimpacted facilities
