Root Cause Analysis of the June 1, 2024, Corral Fire that Disrupted Operations at LLNL's Site 300

Lawrence Livermore National Laboratory,
P.O. Box 808, Livermore, CA 94551-0808

September 6, 2024

Title: Corral Fire Disrupts Operations at Site 300

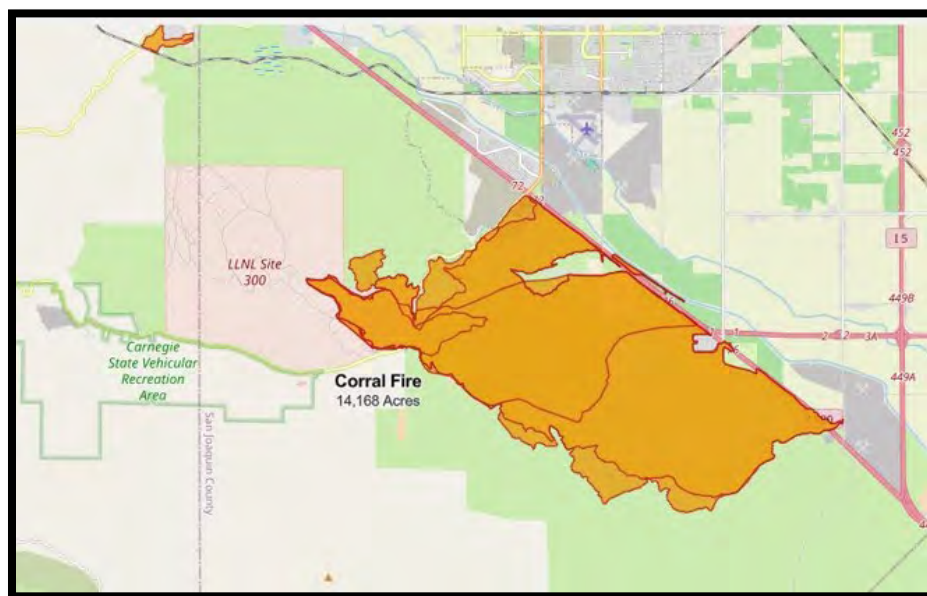
Figure 3. Corral Fire Affected Areas

The Corral Fire was first reported on June 1, 2024, at 2:23 p.m. east of Building 892. It was later determined that the fire started southeast of S300's Substation 846 near distribution pole 8009 and moved southeast of pole 8009, through part of S300 and then continued offsite, burning 14,168 acres. Figure 3 shows the affected areas of the Corral Fire.

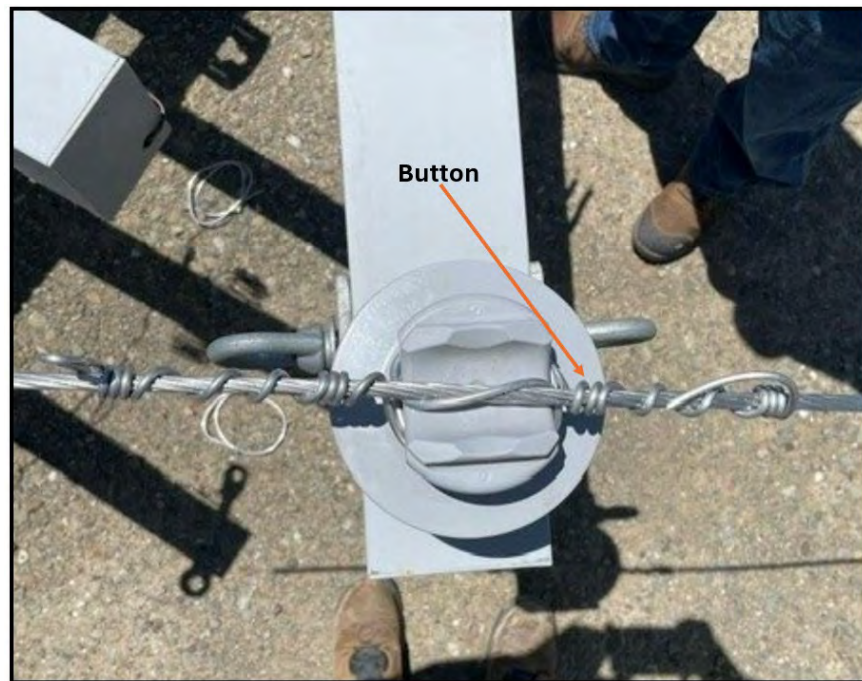
Figure 4. Fastening Method: Hand Tie and Depiction of a Button

1. Hand Tie – Use of #4 AWG bare soft drawn aluminum wire that is wrapped around the conductor and insulator by hand or using hot line tools. Installed hand ties include buttons, where the hand tie is wrapped around the conductor on each side of the insulator (See Figure 4). EUD performs all hand tie installations on de-energized lines by hand.

- **Proper tying method of the hand tie** – It is unknown if the hand tie was or was not tied properly to the insulator. There is no evidence, however, that when the hand tie was installed, the tie overlapped itself around the insulator. An overlap of the tie material can become a wear point due to abrasion, as stated in installation procedures, creating a potential weak point. This seems unlikely, as the equipment on the cross arm was subject to routine maintenance in October 2023, when any abnormality from prior installation would have been identified and addressed. Based on what is left of the hand tie, the remaining portion appears to have the appropriate number of buttons on either side of the insulator (See Figure 4 for a visual description of a button).

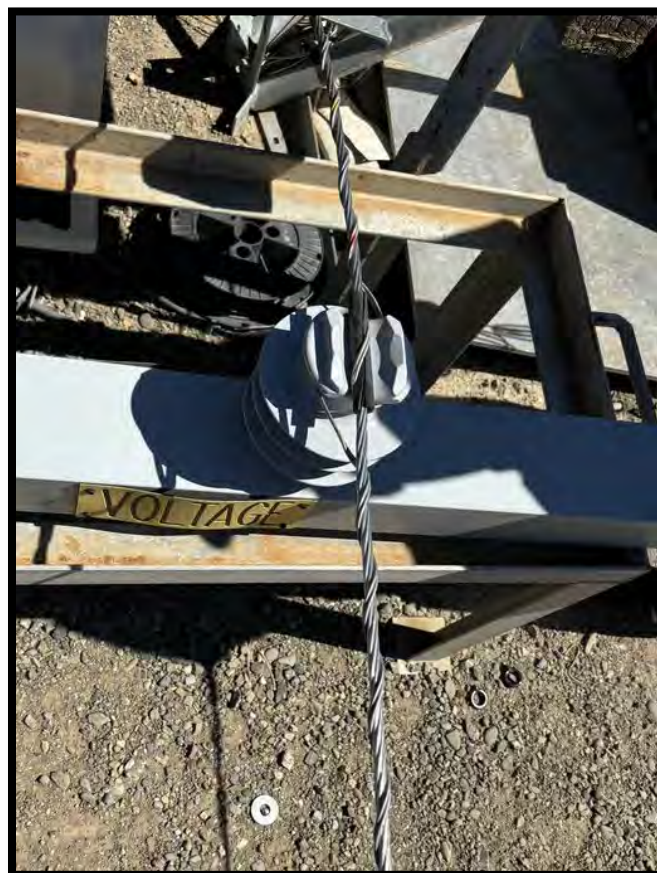
Figure 5. Fastening Method: F-neck

- c. This method has been widely used in the utility industry in the western United States including Pacific Gas and Electric (PG&E).
2. F-neck – a pre-formed steel tie that is also installed by hand (Figures 5 and 7).

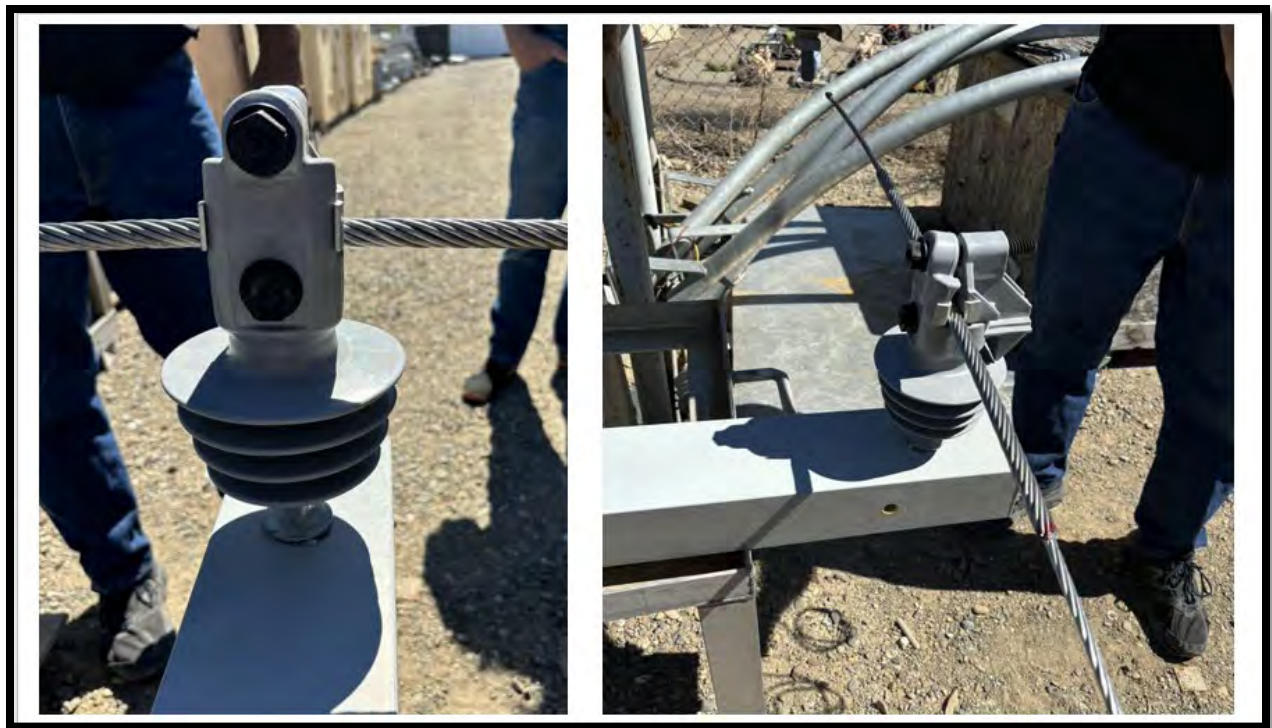
Figure 6. Fastening Method: INSULIGN Vise Top Pin Type Polymer Insulator (i.e., vise clamp)

- c. This method began to be utilized at S300 prior to 2014.
3. INSULIGN Vise Top Pin Type Polymer Insulator (i.e., vise clamp) - utilizes a polymer clamp mechanism and nylon torque bolts to secure the conductor with a break-away ring (Figure 6).

- c. This method has been installed on some poles in S300's feeder 4 for evaluation purposes as insulators were found needing replacement following previous supervisor attendance of The Electric Utility Expo. Such installations began in 2018-2019.

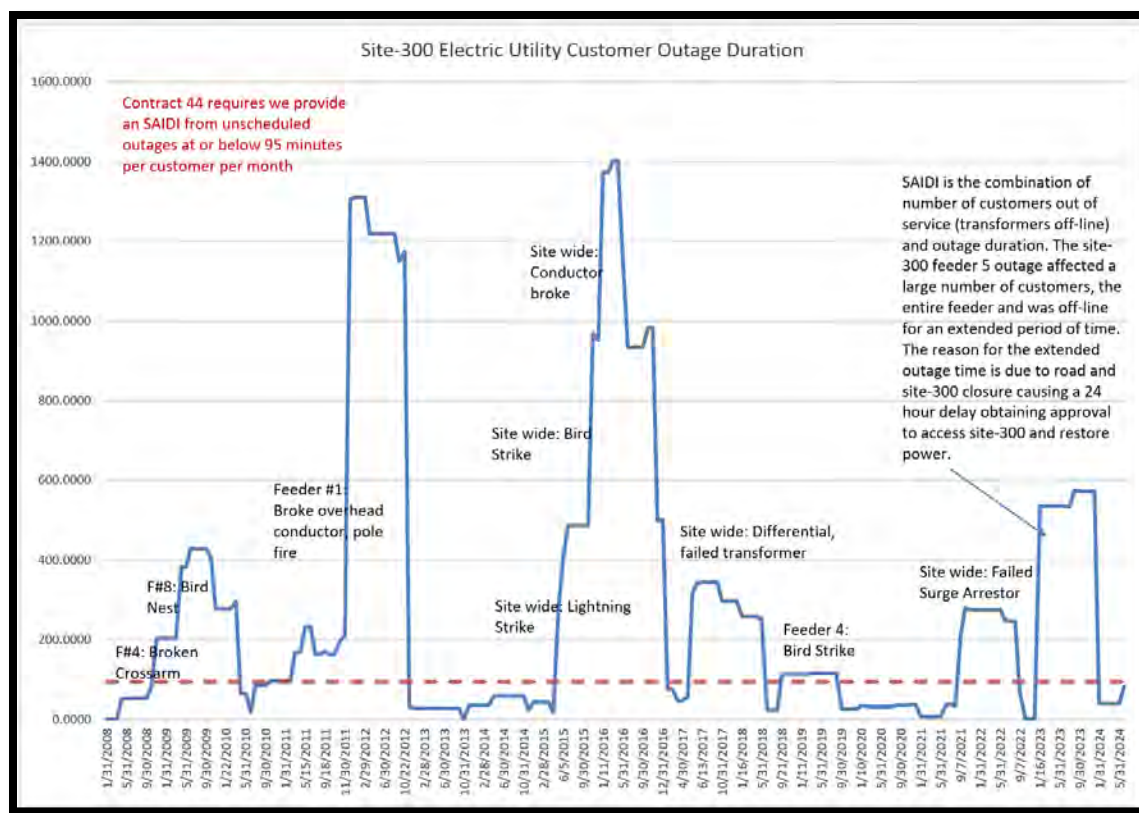
Figure 8. All S300 Sustained Unscheduled Outages Excluding the PG&E Utility Caused Outages

EUD has made a number of improvements over time to inspection and maintenance processes. Figure 8 shows how these improvements have affected the number of outages or faults. Due to the EUD's efforts and improvements the frequency and the severity of electric utility outages have drastically decreased. As seen in Figure 8, the PG&E transmission utility outages have a large effect on the impact of unscheduled outages. Looking at Figure 9, removing PG&E utility outages, the most significant outages labeled with the apparent cause can be seen. If we remove the final large outage, which was sustained due to inability to access the site for over 24 hours due to flooding, it is clear from 2018 that the focused efforts to use bird and animal guards, insulated jumpers, updated composite cross arms, replacing insulators, and weekly line inspections have reduced the number and duration of unplanned outages and increased reliability, without compromising safety. The bird and animal caused outages have been greatly reduced. Weekly line inspections have found mylar balloons and other issues prior to causing a fault. Consistent maintenance with high standards has reduced equipment caused outages. As time goes on, the EUD continues to make system improvements, track, and correct any failure modes seen. The EUD is working hard to make the current system as reliable as possible, utilizing best utility practices and implementing new technology where applicable and where it will make a positive impact.

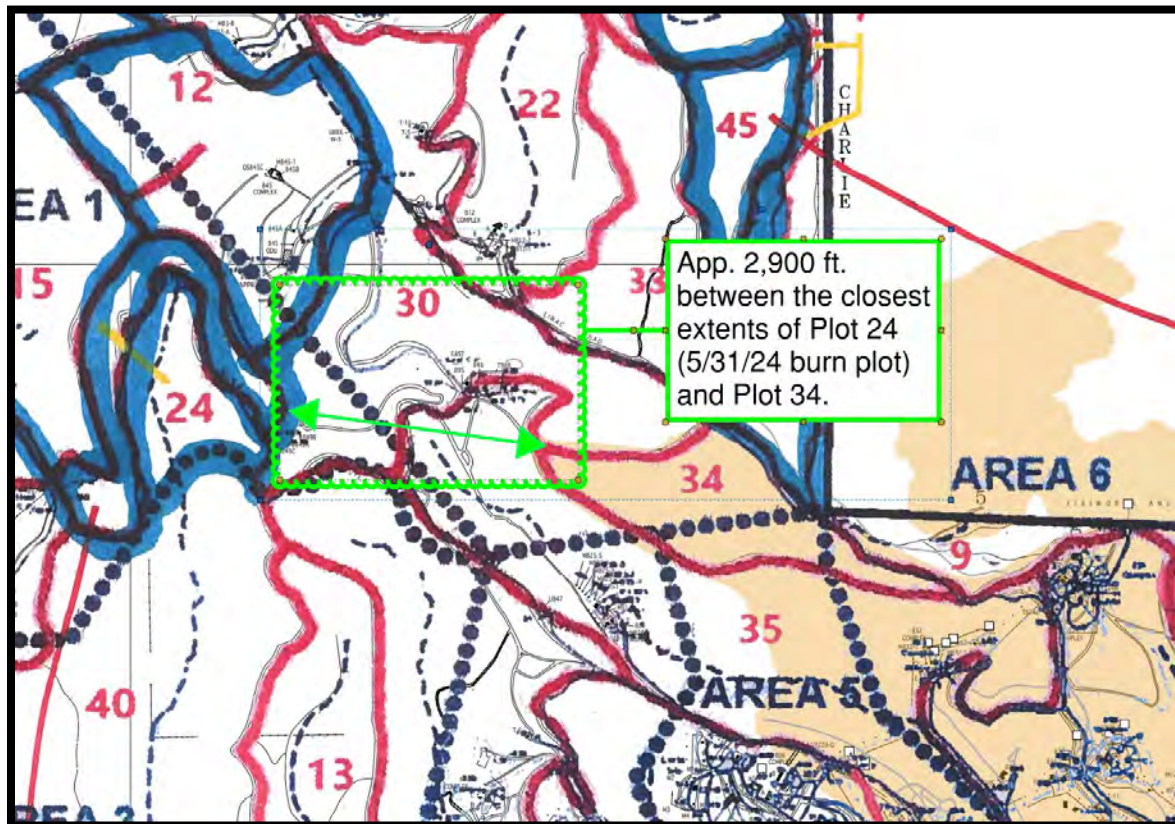
Figure 10. Estimated Distance Between the Last Prescribed Burn (May 31, 2024) and Corral Fire (June 1, 2024)

The distance from the edge of Plot 24, the last prescribed burn that took place on Friday, May 31, 2024, and Plot 34, the western edge of the Corral Fire, is estimated to be 2,900 feet, as shown in Figure 11. The prescribed burn is not analyzed in this report as a barrier or control to prevent ignition of the fire, since that is not the purpose of the prescribed burn, to prevent ignition. However, based on the time and distance between the last prescribed burn and the start of the Corral Fire, there is no evidence that the 2024 prescribed burns ignited the Corral Fire.
